# Careless Construction Causes Nightmare

by Paul Cove

A house I examined recently was only 21 years old and worth a half-million dollars, but required over \$60,000 of structural repairs. Almost 90 percent of the sheathing had failed. Most of the sill, and some of the wall framing had rotted as well. The damage had multiple causes, but the primary problems were:

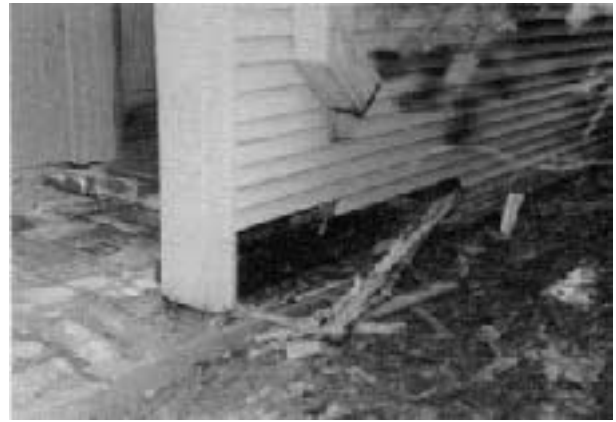
Wood members placed too close to the ground become wet from rain backsplash. As shown in Figures 1 and 2, the siding and sill were virtually touching the ground in places. Furthermore, the top of the foundation projected out beyond the house on two sides, trapping water against the sill.

Figure 1. The siding and sill were within 2 inches of the ground in places, such as this garage wall.

Where water is running down a wall, under it, and is being splashed back from the ground, the damage is predictable. Beveled wood siding, as I discussed in the June 1988 issue (pp. 23-26), should overlap a minimum of one-third its width to prevent water penetration. Also, there should have been flashing or caulking at the corner boards and trim, but there was none. Also, the foundation should have been exposed at least 2 feet above finished grade to prevent back-splash on wood areas.

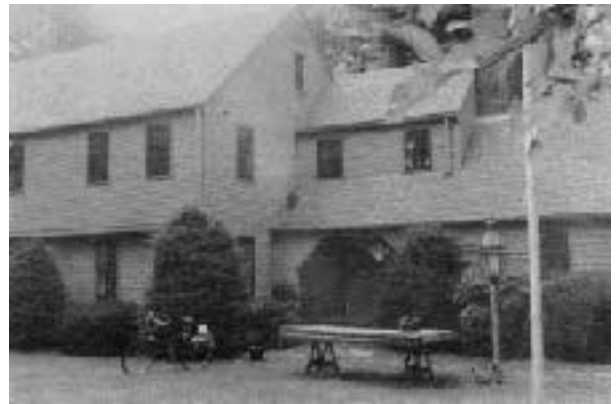
Where there were no gutters, the problem was magnified. Shrubs also increased the problem by slowing down the drying rate of the wood (see Figure 3). In short, wood that is continually moist will rot and invite attack by insects. This house had damage from both, and the damage was worst close to grade.

Figure 3. The shrubbery looks nice, but slows down the drying at the bottoms of the outside walls.

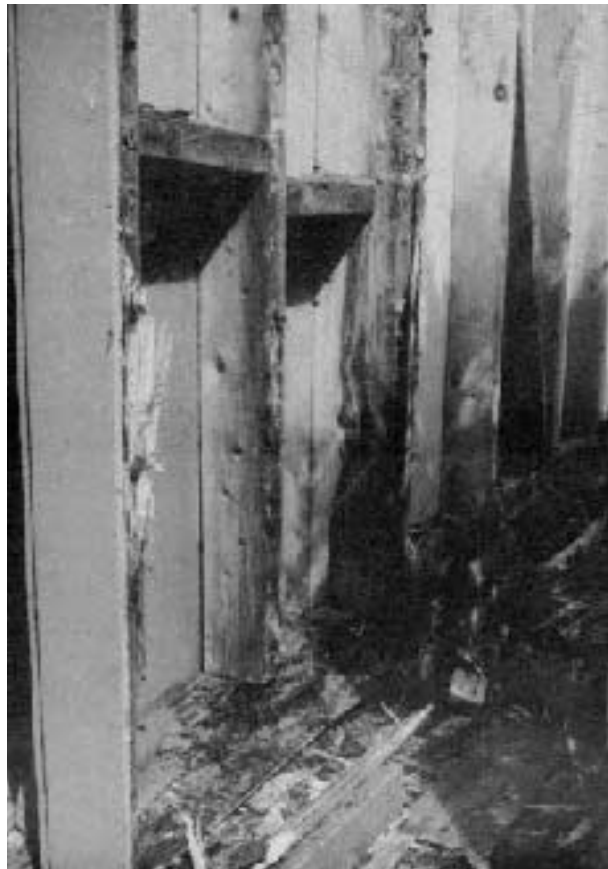
Figure 2. Damage to the garage sheathing and framing extended from grade to 6 feet up.

The sheathing suffered the worst delamination on the exterior face, indicating that the main source of moisture was the penetration of exterior water, not condensation from interior air. Furthermore, the damage was uniform around the house, in both the heated and the unheated areas. For example, the damage in Figures 1 and 2 are in the walls of an unheated garage, where condensation would not come into play. Damage to the garage framing extended up to 6 feet above grade.

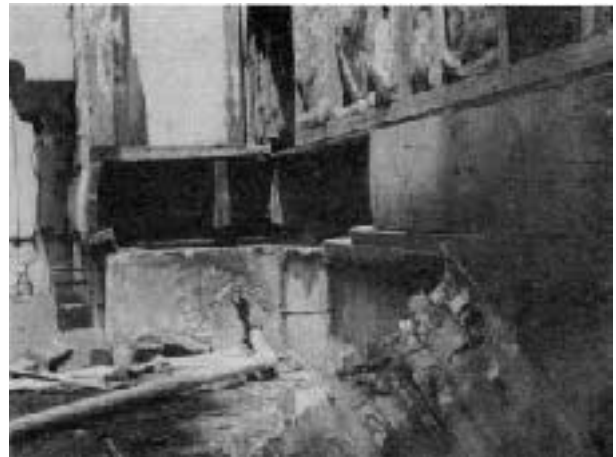
was a double 2x4 set so it overhung the foundation in many areas by 2 inches (see Figure 4). The sill was off-set like this to compensate for errors in the foundation dimensions. It was also not secured to the foundation. As the sill rolled out, the band joist sagged and cupped, causing settlement and cracking of the interior walls.

This area shown in the photo was hidden behind an attached deck, and suffered rot and termite damage in the plates and joist ends.

Figure 4. The double 2x4 sill was falling off the foundation due to its cantilevered placement.

Finally, the sill should have been wider, anchored to the foundation, and lined up properly with the foundation. Common sense should have dictated that the building load be on the foundation walls, not on a flat 2x4 in midair. But common sense was the ingredient most lacking on this building project. ■

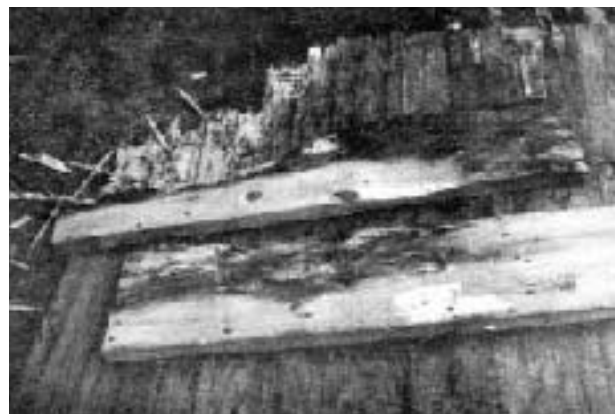
Damage was not limited to the lower portions of the building. Figure 5 shows the extensive damage caused by rot at the second-floor band joists where they overhang the first floor.

Figure 5. The second-floor band joists at the overhand suffered substantial rot.

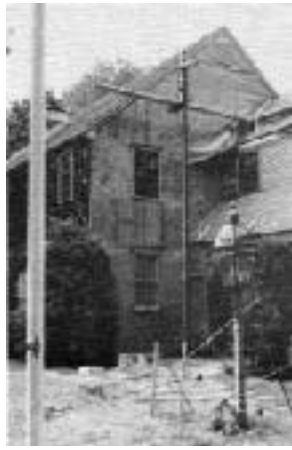
Figure 6 shows the extent of repairs – nearly all the sheathing was replaced. The areas that suffered the least damage were at the top of the walls where some protection was offered by the small roof overhang. The most severe damage was close to the ground.

**Figure 6.** More than 90 percent of the sheathing had to be replaced due to moisture damage and delamination.

using interior-rated sheathing as this was stamped clearly on every sheet. The least damage occurred near the roof where a small overhang protected the wall from the elements – a good example of the protection a large roof overhang gives a structure.
