Cupola Maintenance

by John Leeke

I was called to look at the cupola on the Memorial Building in Stowe, Vt. It is a finely detailed Colonial Revival building put up around 1900. Local officials have realized the importance and special character of the building,

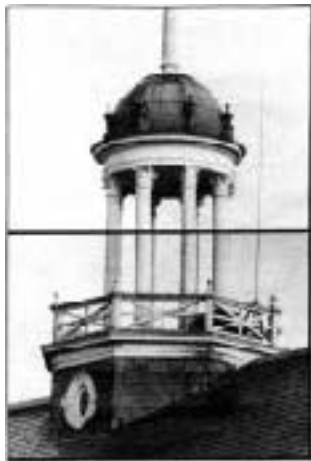
Figure 1. This composite photo shows the dome-roof structure on top of this cupola, which may have to be removed by crane to install new or reconditioned columns. Notice the Corinthian columns and the copper urns — just some of the fine detail.

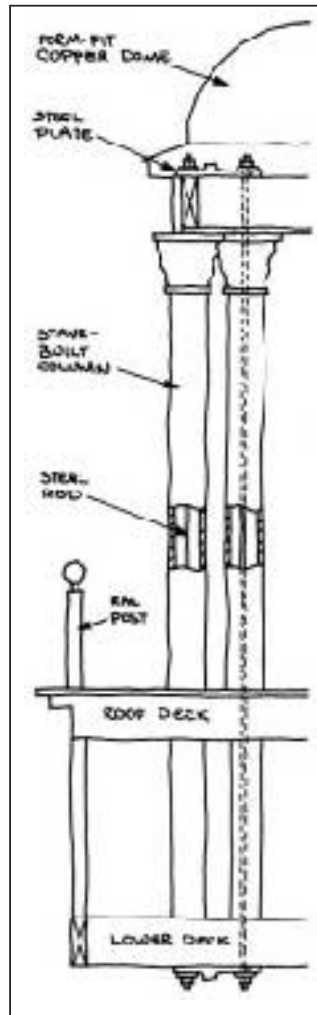
Figure 2. The cupola has two decks: a roof deck and a lower deck. The roof deck supports eight wooden columns that act as spacers between it and the dome roof. Eight steel bolts run through the hollow columns and tie the structure together.

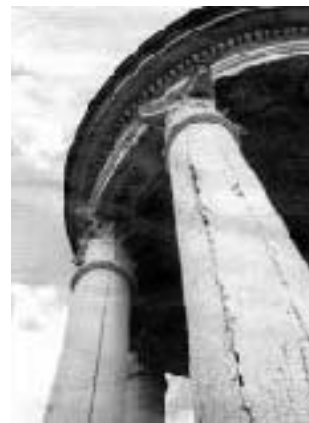
On all the exterior wood, the paint had alligatored and peeled right down to bare wood because of heavy buildup. This old paint system no longer gave the decorative and structural woodwork the protection needed to stand up to the severe weather exposure. Often, a thick coat of paint doesn't flex with the wood beneath. It cracks, usually all the way through, letting moisture into the wood beneath. That causes peeling and allows in even more moisture (see Figure 3).

Figure 3. A thick coat of paint doesn't flex with the wood beneath. In this case, 15 coats of paint cracked and let in moisture.

The irregular and spotty condition of the existing paint means that the ordinary approach of spot scraping and full recoating will not work. All the old paint will have to be removed for a fresh start. In this case I have recommended the removal of all the paint, right down to bare wood, although traces of the original primer are acceptable. Next, they should sand all surfaces with 100-grit paper to clean and prep the surface. Finally, they should prime and recoat with two top coats of linseed-oil-based house paint, sanding between all
