Replacing a Slab Foundation

When the original builder flubs a foundation, someone else has to clean up the mess

by Mark Reinmiller

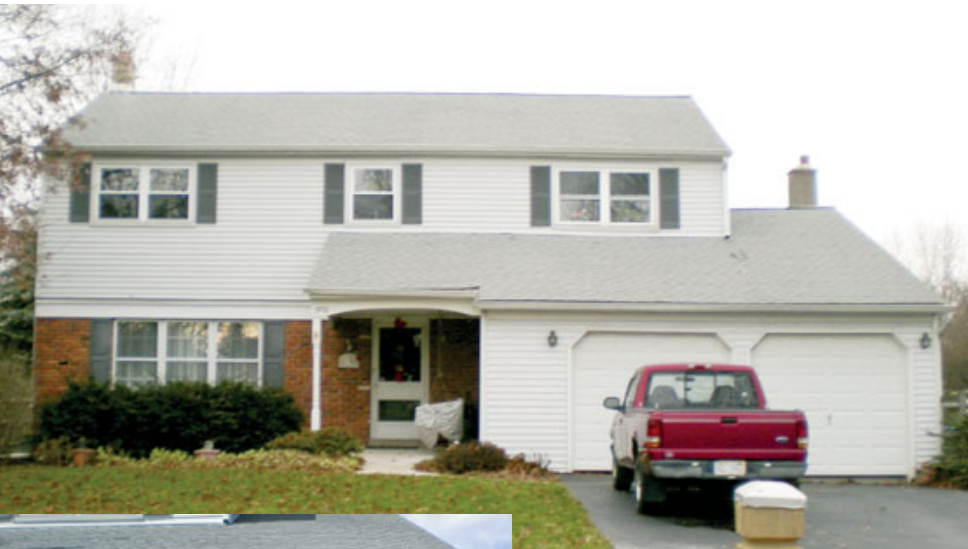
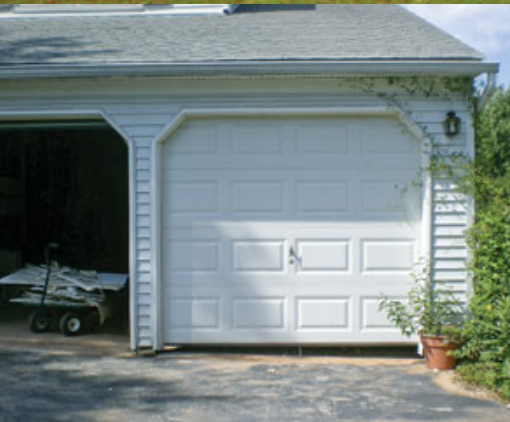
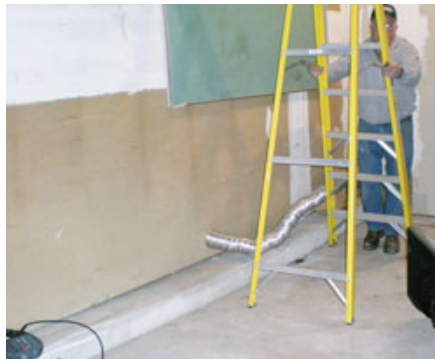
The sinking garage slab had left a huge gap at the base of the garage doors (see **Figure 1, page 2**), and the doorway from the main house to the laundry room was so badly distorted the door would no longer open, forcing the homeowners to gain access by walking around through the garage. The settlement was also responsible for a pronounced sag in the second-story master bedroom above the garage.

Figure 1. Careless site preparation at the time of construction left this 30-year-old home with a sinking driveway, a cracked and leaking sewer line, and failed slabs in the garage and the family room behind it (top). The gap beneath the garage door (above left and left) was a full 8 inches high at the right-hand side. At the back of the garage, the laundry-room wall was separating from the slab (above).

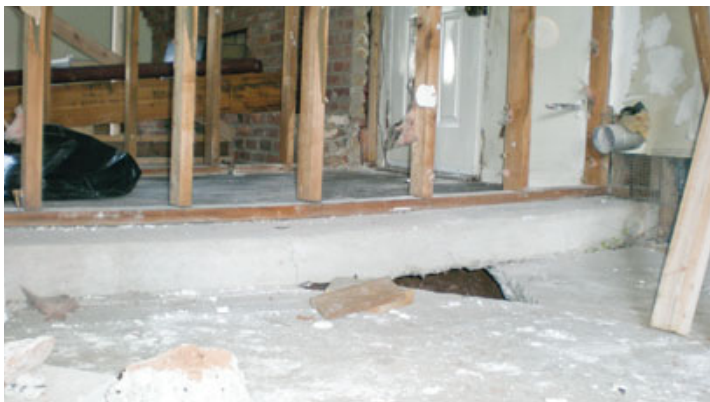
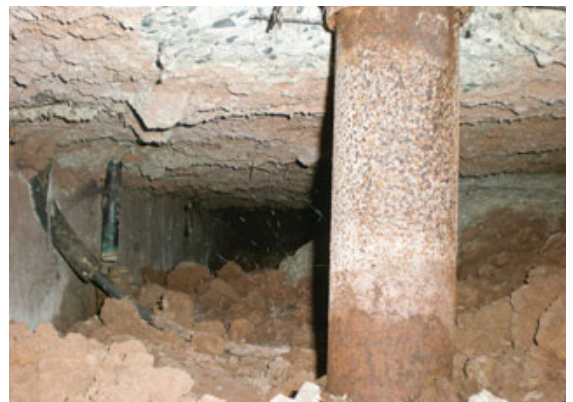
In addition to confirming a wide gap between the soil and the slab, the images revealed that the drain to the powder-room basin had separated from the building sewer line (**Figure 2**). This wasn't much of a surprise, since an earlier video inspection by a plumbing contractor had already shown that the sewer line sloped back toward the house, leaving it prone to backing up. When we eventually dug out the soil around the pipe, we found that the cast-iron sewer line was sheared completely in half where it passed through the garage. Fortunately, the broken ends must have remained in close contact with one another, because there was no obvious sewage odor, even though

Figure 2. With the drywall stripped from the laundry-room and family-room walls, the sag in both slabs is evident (left). Note the inspection hole in the concrete, which allowed the author to take this photo (right), which shows a large gap between the slab and the soil beneath and, at the back, a disconnected waste line.

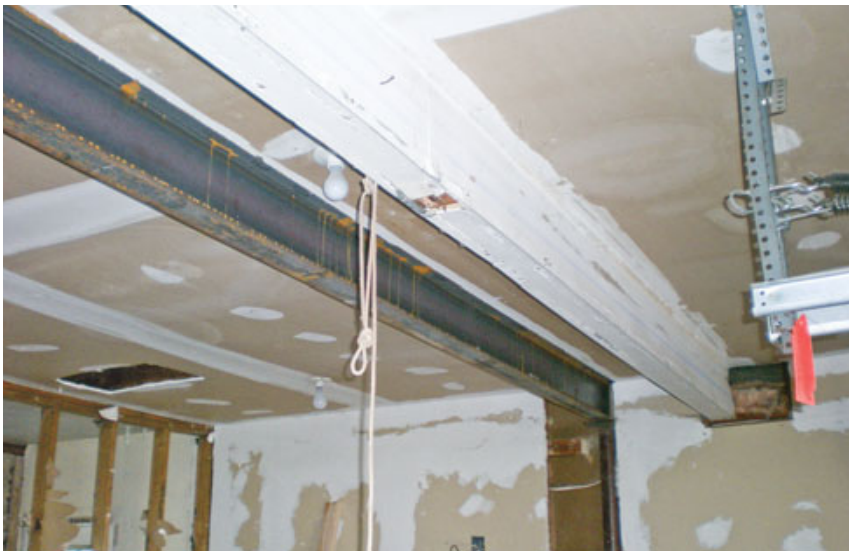
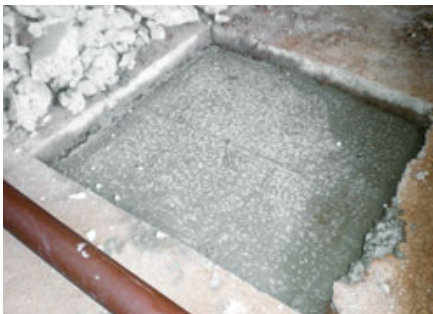
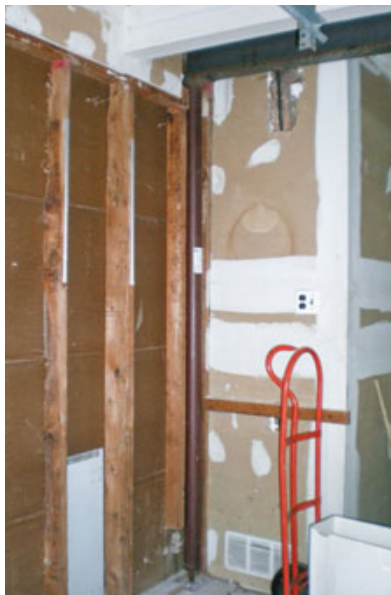
Figure 4. This drywall-covered built-up wood beam (top) was offset 2 feet from the front eaves wall it was meant to support. To correct the faulty load path, a new steel I-beam, supported by steel posts at each end (right), was installed in the correct place. A new footing was poured for a steel post at midspan (above).

Bad bearing. The initial investigation also revealed that there was no footing under the studwall between the laundry room and the family room; this wall carried the floor load from the bedroom overhead. And we found that a wood girder in the garage ceiling that was supposed to carry the second-floor eaves wall was actually 2 feet in front of it, placing a large point load on the upstairs floor joists. A column at midspan was bearing directly on the sagging slab below, without benefit of a footing.

Steel in the right place. The first order of business, before we could begin excavating, was to get the second-story loads onto proper footings. We started with the front eaves wall. The fact that the original carrying beam was in the wrong location worked in our favor, since it allowed us to put the new beam in place without having to remove the old one.

We thought about going with a steel I-beam beefy enough to span the entire 20-foot width of the garage, but the large beam required would have been too difficult to jockey into position. Instead, we chose a beam big enough to support just the dead load over the full span. Once it was in place, supported by steel columns at each end, the excavation contractor cut through the existing slab and hand-dug a hole for a footing at midspan, finally reaching undisturbed soil 54 inches below the slab (Figure 4, page 4). After pouring the concrete, we placed a new steel column that broke the span in half so the new I-beam could safely carry the combined live and dead loads.

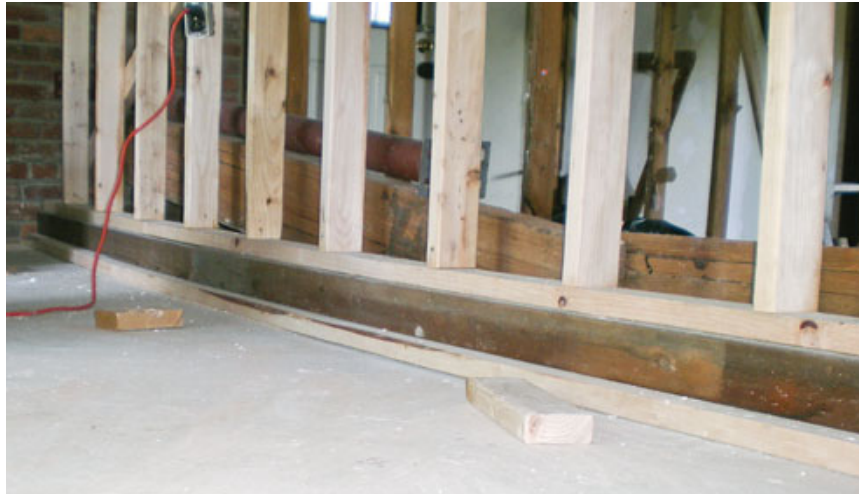
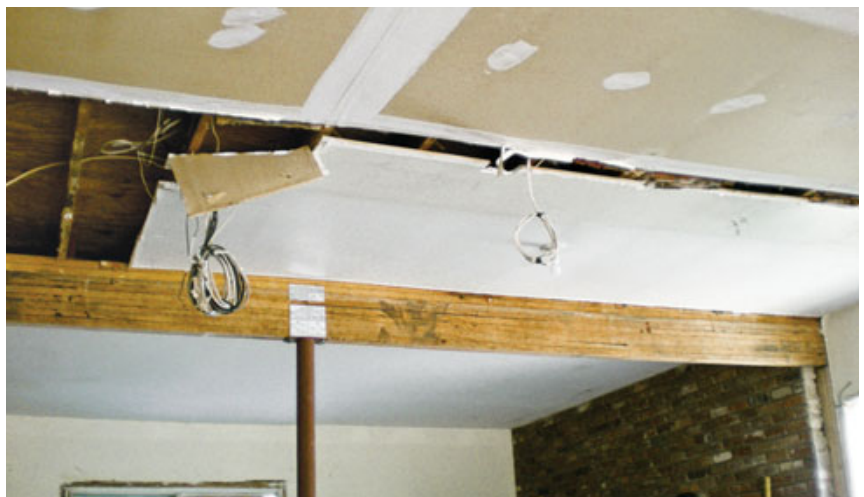
Figure 5. Before removing the improperly supported bearing wall in the family room, the GC built this temporary support wall (top). Note the wide bottom plate, meant to spread the load as much as possible over the settling slab. Once the bearing wall was gone, a pair of glulam beams was installed overhead, supported at midspan by a steel post on a new footing (above).

supported, we turned our attention to the bearing wall between the laundry room and family room. We felt that cutting through the slab to install a continuous footing would be too risky, because it would leave the second-floor joists without adequate support while the work progressed. Instead, we built a temporary support wall parallel to the existing wall, about 2 feet away. Like the original wall, the temporary wall rested directly on the sagging slab, but it was nailed to a heavy pressure-treated plate to distribute the load as uniformly as possible (Figure 5). We then removed the old wall, cut through

the slab and poured a new footing, and supported the floor loads with a pair of glulam beams that butted together over a new column at midspan. We considered using another full-length steel beam, but decided, given the relatively confined space, that it would be much more difficult to maneuver than a pair of glulams. Also, the glulams were easier to integrate into the wood frame walls at each end.

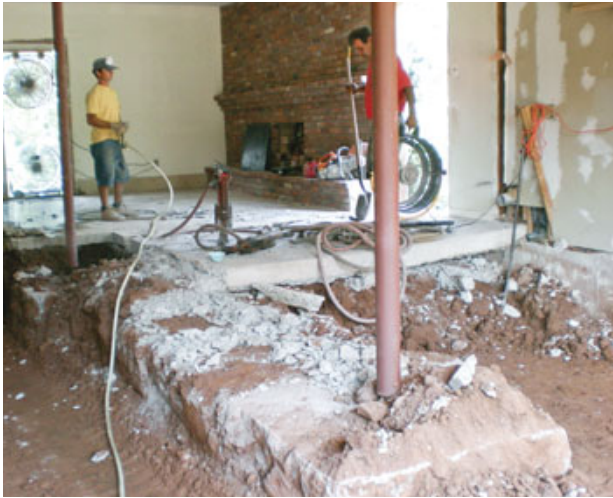
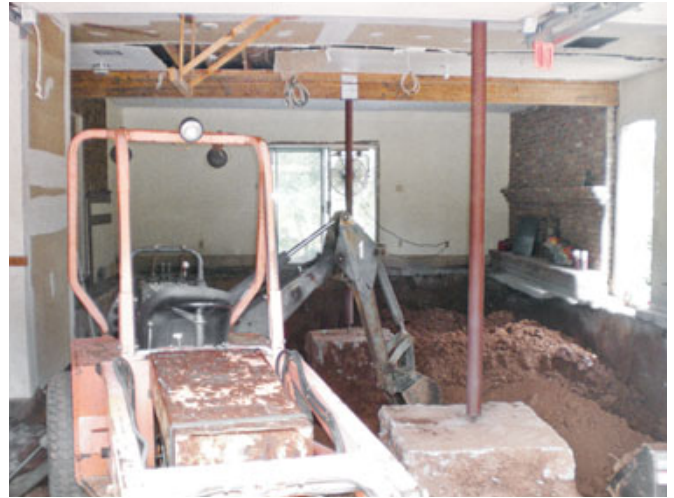
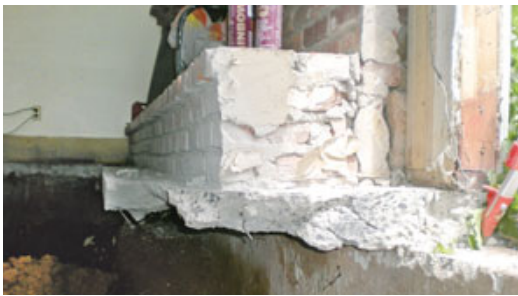
Figure 6. With the second-story loads permanently supported, slab demolition (above left) and excavation (above) could take place. Because the exterior framing sat on top of the slab, it was simpler to cut the concrete cleanly at the inside edge of the perimeter wall. The weight of the brickwork above the family room hearth (left) proved sufficient to hold the hearth extension in place until new support walls could be provided in the crawlspace below.

Dealing with the garage slab was a straightforward matter of breaking it into manageable chunks with demolition hammers and hauling away the rubble (Figure 6, page 6). But removing the laundry-room and family-room slab was complicated by the fact that its edges extended over the top of the side and rear foundation walls. Both the exterior wall framing and the fireplace brickwork at the end of the family room sat on top of the slab, and removing that portion of it would add a lot of work and expense.

Instead, the mason's crew cut the slab as close to the inside face of the exterior walls as possible. After making an initial cut with a gas-power concrete saw, they trimmed it back closer to the wall with an electric concrete saw. This left a suitable ledge for the sill plates that would later support the family-room floor joists.

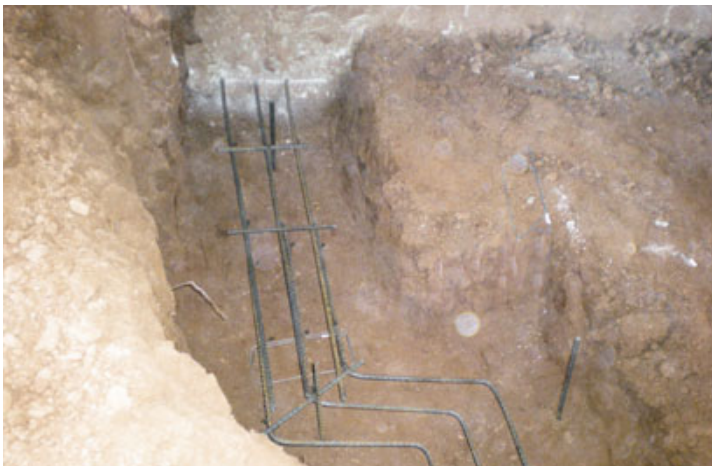
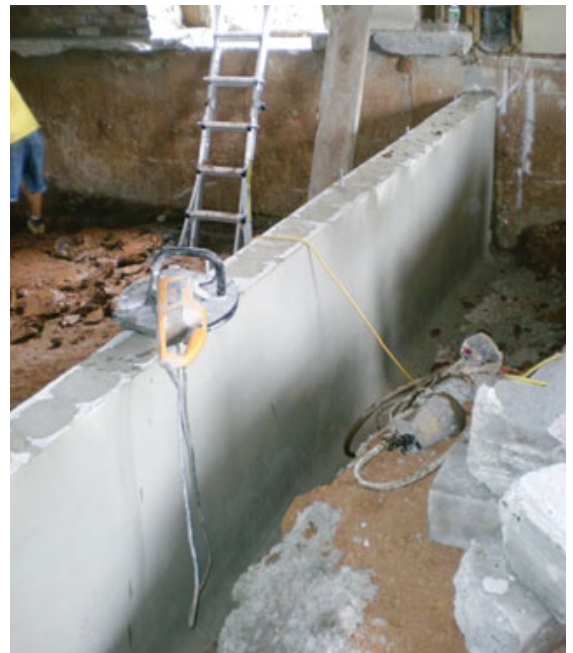
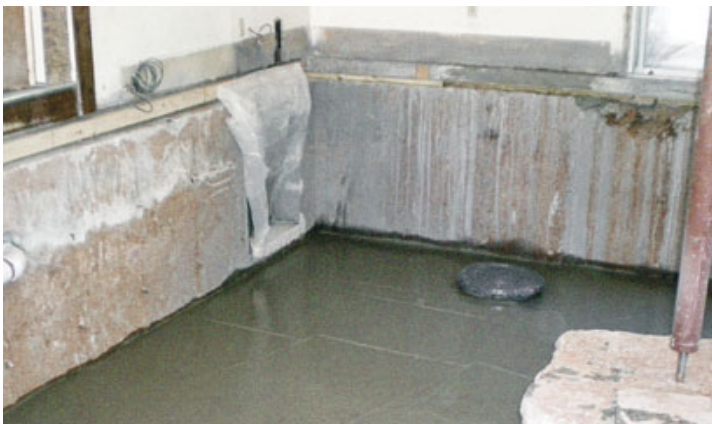
Figure 7. A new steel-reinforced footing, anchored to holes drilled in the existing perimeter wall (above left) supports a block foundation wall between the laundry room and garage (above). An access opening between the new crawlspace and the existing basement (left) was cut with a concrete saw equipped with a diamond blade. Note the sump cover.

Once both slabs were hauled away, the crew excavated the soil below the floor slabs with the aid of a skid steer and a small backhoe. We then poured a steel-reinforced footing and built a block wall at the rear of the garage to provide support for the new floor joists and to separate the crawlspace from the fill below the garage floor slab (Figure 7, page 6).

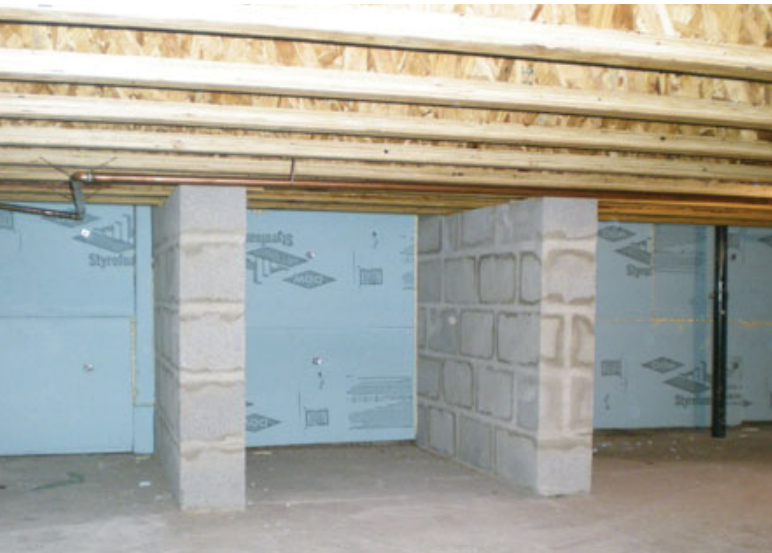
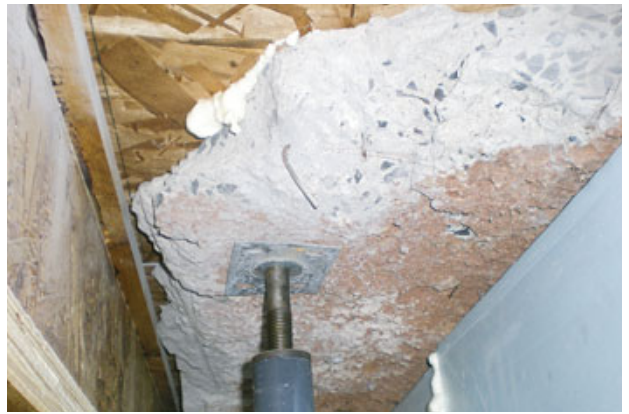
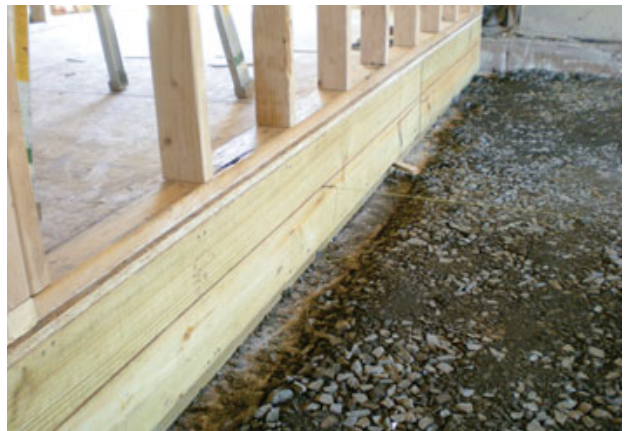
Figure 8. The existing hearth extension gained additional support from a pair of short block walls and the short steel column visible at far right of photo (above). The column's upper end was tightened against the cantilevered section of slab; a few squirts of polyurethane foam prevent squeaks between the slab and the OSB floor sheathing (above right). After the new laundry and family-room floor was framed and sheathed, the garage area was backfilled with compacted gravel in preparation for the new slab (right).

In addition to pouring a new garage slab, we poured a second slab in the new crawlspace, and provided access by cutting an opening from the adjoining basement with a concrete ring saw (Figure 8). The masons also built two short support walls beneath the cantilevered hearth extension, adding a steel column at the one unsupported corner for good measure.
