An Energy Retrofit in Stages

In the real world of tight budgets, energy paybacks are elusive; improved comfort is the payoff

by Jim Olson

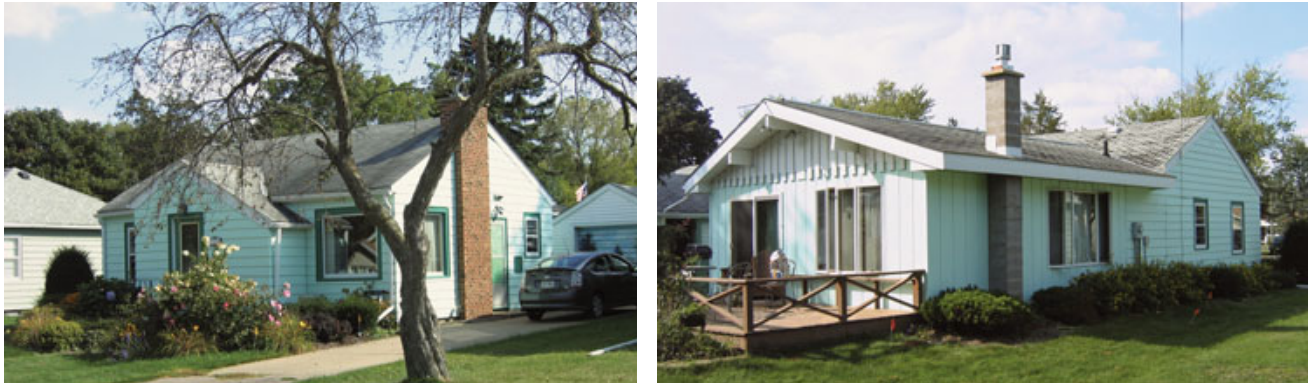
Figure 1. While located in a pleasant residential neighborhood, the original “farmer’s widow house” was drafty and poorly insulated (left). A 1970s addition off the back (right) added much-needed square footage but suffered from the same poor energy performance. In addition to leaving the siding exposed to rain and weather, the absence of eaves overhangs in the front created a visually awkward transition to the broad eaves in the rear.

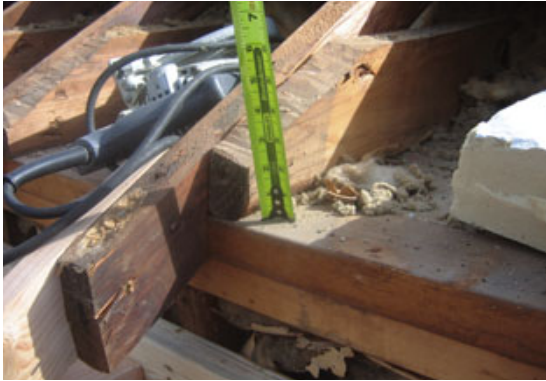
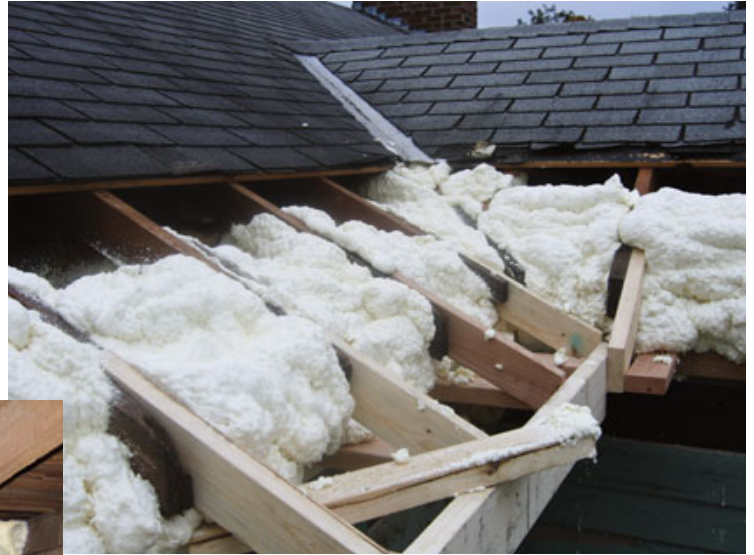
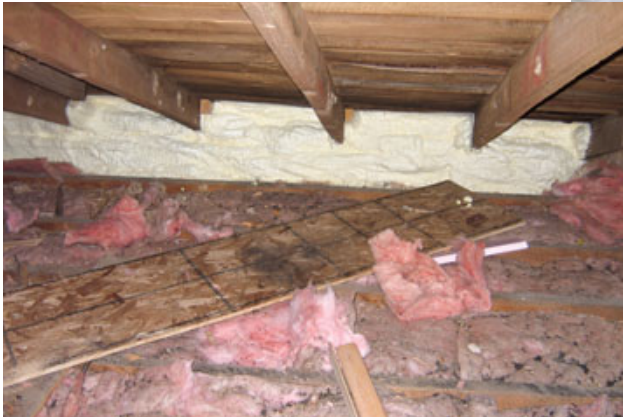
Figure 3. Because the original 2x4 rafters left little space for insulation at the eaves (top left), the area was filled with medium-density spray foam (above), which blocked air leaks and also provided a continuous dam for the cellulose that would be blown into the attic (left). Where excess foam bulged beyond the eaves extensions, the crew cut it away with a sharp handsaw.

Eaves extensions and foam. Most of the attic was deep enough for us to blow in an R-60 layer of loose-fill cellulose, but the low-sloped 2x4 rafters left little room for insulation at the eaves (**Figure 3, page 3**). To provide sufficient R-value here, eliminate a major source of air infiltration, and supply a protective roof overhang, we pulled off the lower part of the plywood roof sheathing, extended the framing at the eaves, and sprayed the area over the plate and some distance into the attic with Versa-Foam 1.8-pound polyurethane foam, which we ordered directly from the manufacturer. In limited areas where the foam expanded outward beyond the plane of the framing, we cut away the excess foam with a sharp toolbox hand-saw. The gable-end overhangs now tie in neatly with the eaves of the rear addition, doing away with what had been an awkward transition. At the front of the house, where the tops of the windows were high on the wall, we scaled back the overhang a bit to keep from shading the interior too much.

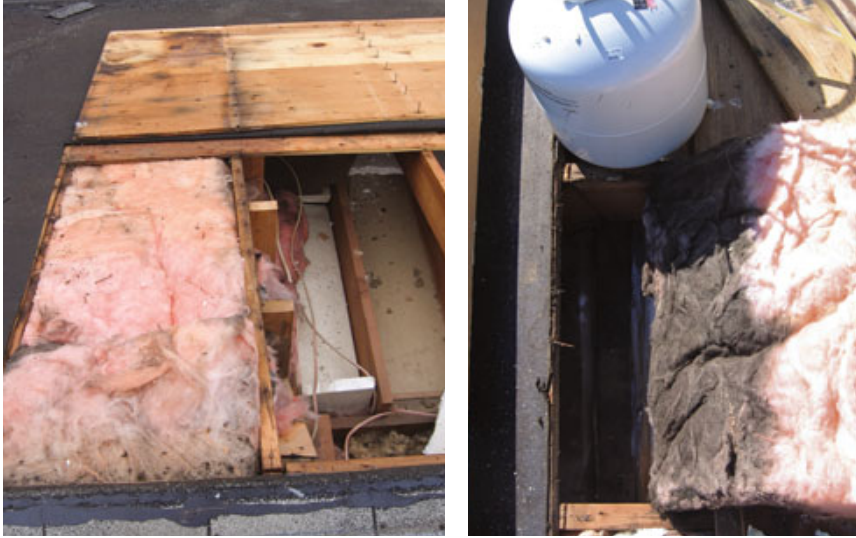
Figure 4. At the interface between the addition and the original attic, warm, moist air flowing through the batts in the cathedral ceiling had been condensing on the sheathing, rusting the nails and staining the plywood (left). Along the addition's ridge, air leaking from inside had left a dirty deposit in the batt insulation (right).

Drafty fiberglass batts. After stripping the old roof, we discovered beneath the sheathing of the cathedral-roofed addition some classic signs of an insulation system that wasn't working too well (Figure 4, page 4). Warm, moist interior air had clearly been moving freely through the insulation for years, cooling and condensing against the plywood roof sheathing and leaving some sections of the batt insulation looking like dust-clogged air filters. Although there was little evidence of decay, the plywood was discolored and the nails fastening it to the rafters were badly rusted.

Rather than tear off all of the sheathing and remove the batts, I decided to remove the sheathing only in areas where our blower-door tests had confirmed the presence of leaking air. We cut away a strip running the length of the ridge and foamed the peak from above, blocking air that had been making its way through the cedar paneling. (A poly vapor barrier stapled to the underside of the rafters when the addition was built effectively slowed air movement through the field, but did nothing at the roof peak and edges.) We used additional foam and some sheets of beadboard to air-seal the transition between the framing of the original house and the roof of the addition.

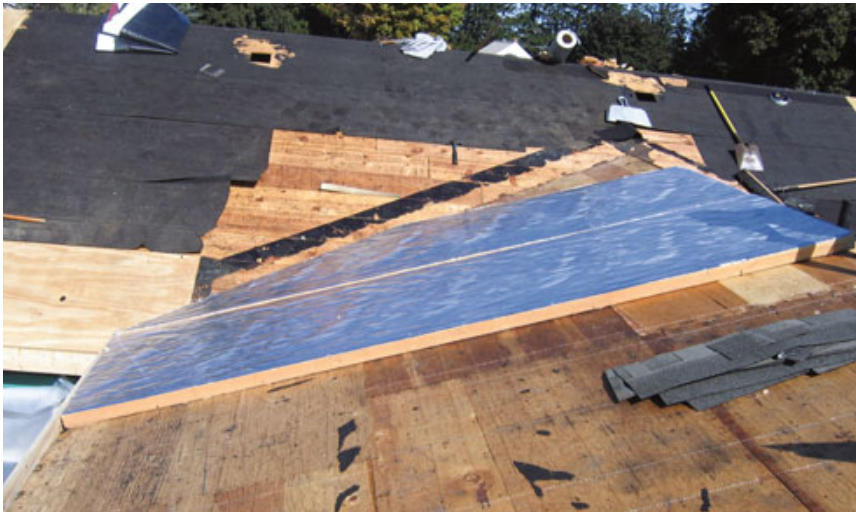
Figure 5. Foil-faced polyiso board, screwed to the addition roof deck (top), supplements the original batts, which were left in place between the rafters. Joints between panels — and the intersection with the board deck of the original house, visible at rear — were sealed with spray foam. The gable-end rake of the original house was extended to meet the addition overhang, providing improved weather protection and a cleaner appearance (right).

Exterior foam. Through a local commercial builder, I got a great deal on about a hundred 4-foot-by-13-foot sheets of foil-faced polyiso board left over from a large job. With the air leaks in the roof taken care of, we laid the sheets of foam board directly on top of the plywood, butting

them against a new subfascia sized to cover the edges of the foam and the plywood sheathing that would go on over it (Figure 5, page 4).

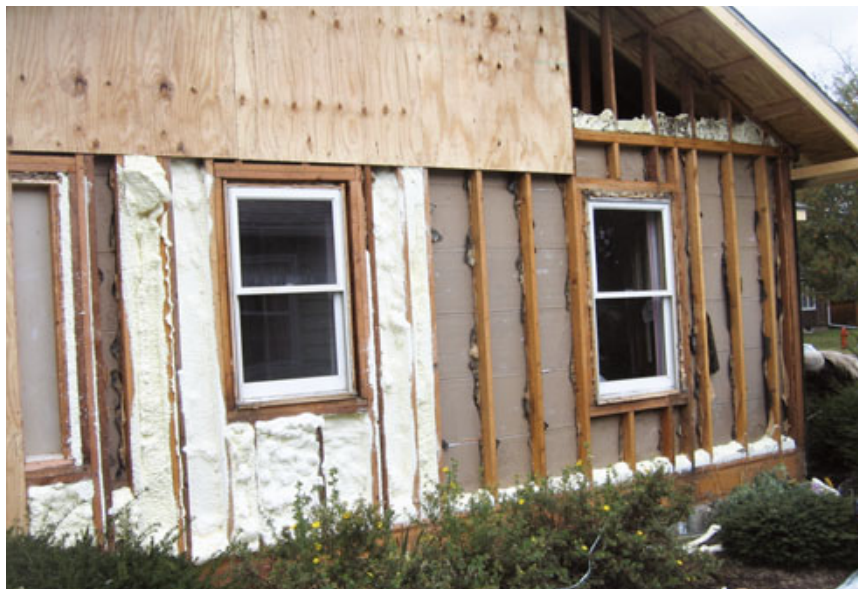
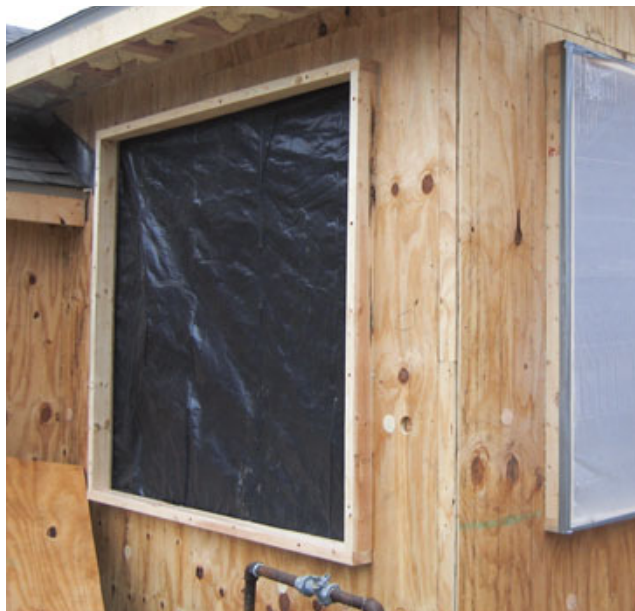
Figure 6. With siding and sheathing removed, potential leaks in the plates were easily sealed with foam (above). Also, as a preventive measure, the exterior bathroom wall was foamed. While nailing up the new sheathing (left), the carpenters took the time to bore holes over each framing cavity — much to the appreciation of the insulation sub who would later fill them with dense-pack cellulose.

ping the walls to the stud cavities, putting up new sheathing and dense-packing the stud cavities with cellulose, then applying a continuous layer of the same polyiso board we'd used on the addition roof (Figure 6).

we nailed up the new 7/16-inch plywood, we predrilled a 2 1/8-inch hole over each stud cavity. That saved a lot of time and effort for the insulation contractor who later filled the walls with dense-pack cellulose, and also assured us that all of the cavities were filled. While the walls were open, we also applied some spray foam around the top and bottom plates, where both the blower-door test and the infrared images had indicated a lot of air leakage. To eliminate any possibility that high indoor vapor pressure in the bathroom could drive moisture into the framing cavities, we completely filled the stud cavities of that short section of exterior wall with spray foam.

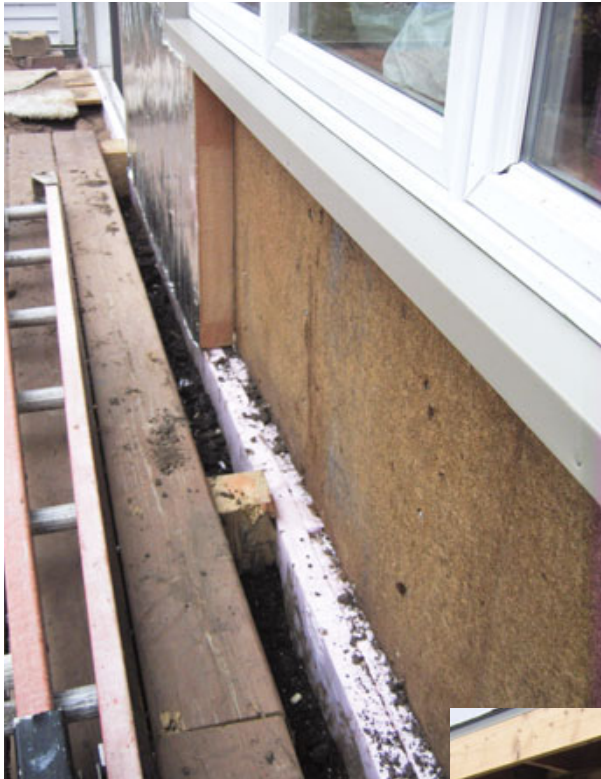
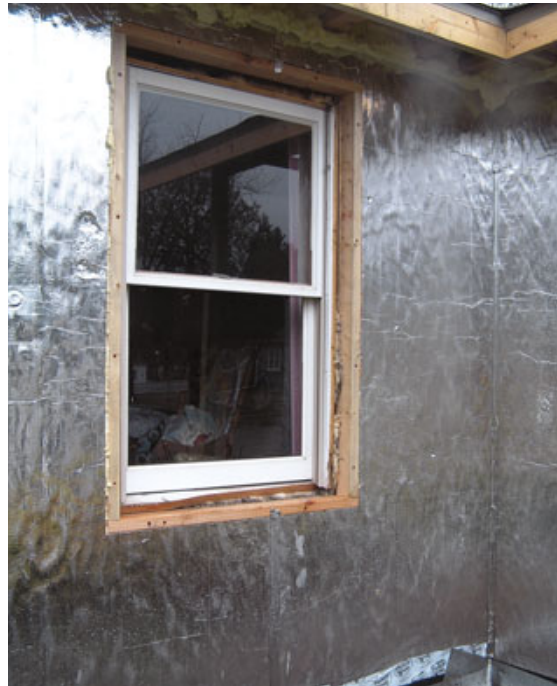
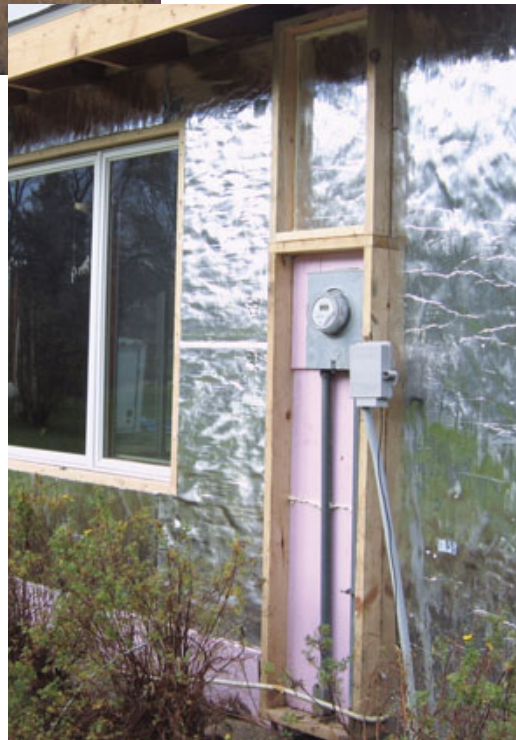
Figure 7. The perimeter of the slab-on-grade addition was insulated with two layers of 1½-inch extruded polystyrene (above left), matching the thickness of the polyiso on the walls (above). Rather than go to the expense of moving the electric meter away from the wall to accommodate the full thickness of the polyiso board, the crew boxed in the area around the meter and filled it with a thinner layer of XPS (left).

We insulated the perimeter of the foundation with two layers of 1½-inch XPS, digging by hand to a depth of 18 inches or so and packing the soil back around the foam (Figure 7). The exposed foam was later covered with a protective layer of galvanized coil stock (which doesn't dent as easily as aluminum).

we had to get creative in a few areas. We couldn't fit a layer of the polyiso board behind the electric meter, for example, and didn't want to go to the time and expense of having the power company move it. Instead, we insulated behind the meter with a single layer of 1½-inch XPS and boxed around it from the bottom plate to the eaves, which made for a cleaner-look-

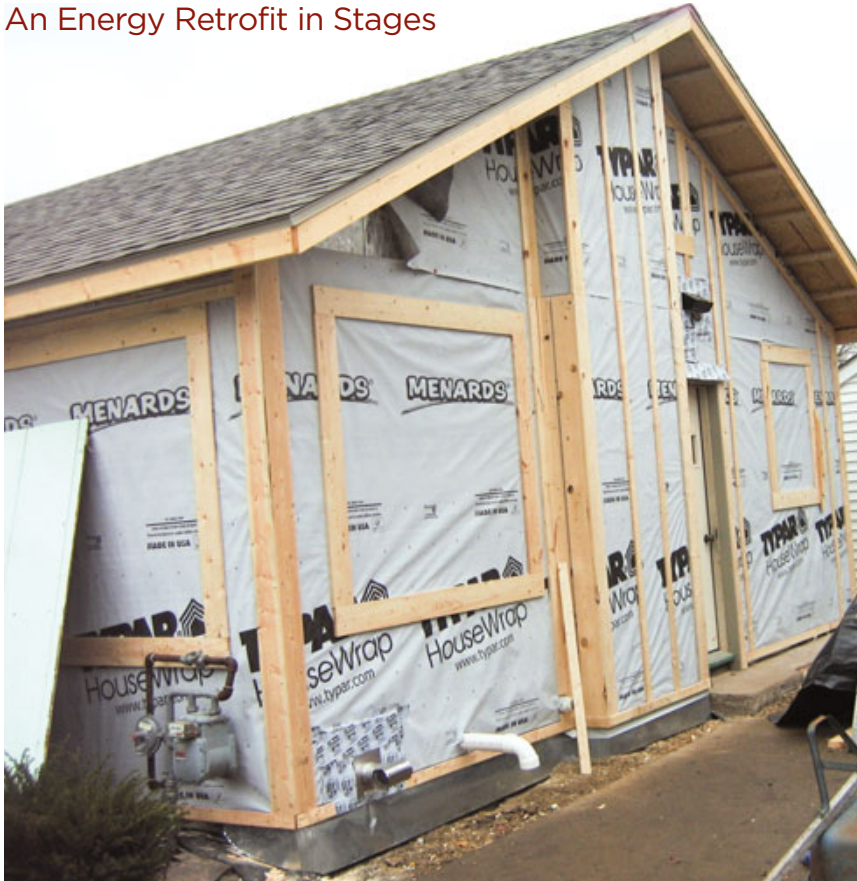
Figure 8. After dismantling the old gable-end chimney above the roofline, the crew enclosed the lower part in a framed, insulated bump-out. The vertical strapping over the bump-out — not yet complete on the rest of the wall — is a rain-screen nailing base for horizontal fiber-cement siding.

The original fireplace was no longer operable, and after we replaced the atmospherically vented gas water heater, the masonry chimney was no longer needed. To eliminate it as a major source for exfiltration, we cut it off at the roofline, capped it, and enclosed it in an insulated chase that lay completely under the overhang (**Figure 8**). This was easier on the budget than taking apart and disposing of the entire chimney, and it even added a small amount of thermal mass inside the new thermal envelope. Looking ahead, the insulated space within the old chimney will make a convenient chase for running wiring or plumbing for a roof-mounted PV or solar-thermal array.

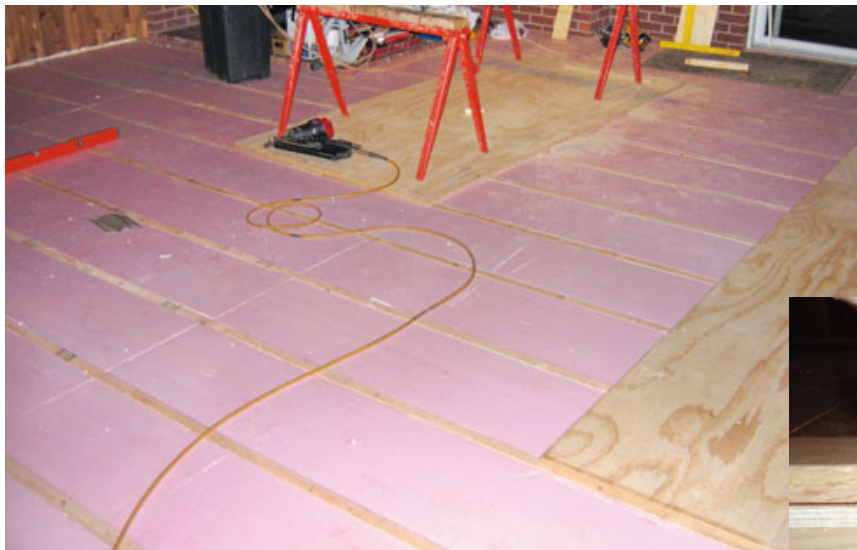
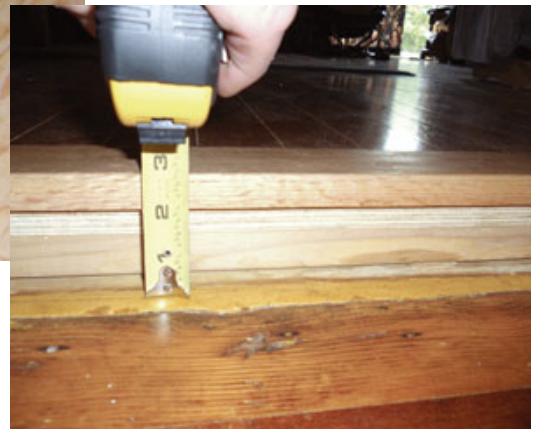
Figure 9. Once stripped of carpeting and tested for moisture, the slab floor of the addition was insulated with XPS foam board fit tightly between lengths of 2-by furring (above). Including the insulation, the finished floor, consisting of $\frac{1}{2}$ -inch plywood and $\frac{5}{8}$ -inch prefinished oak, raised the room's threshold by almost 3 inches (right). A gently sloped transition was added later.

The concrete slab floor in the addition had been covered with carpeting. When we peeled it up we found no signs of mold or moisture, and a cup test confirmed that moisture wasn't a problem. We fastened nominal 2x2 sleepers to the concrete and fitted cut-to-size sheets of $\frac{1}{2}$ -inch XPS between them (**Figure 9**). We then put down an oak finish floor, raising the level

of the original floor by nearly 3 inches. Fortunately there was room to accommodate this with a gently sloped threshold.

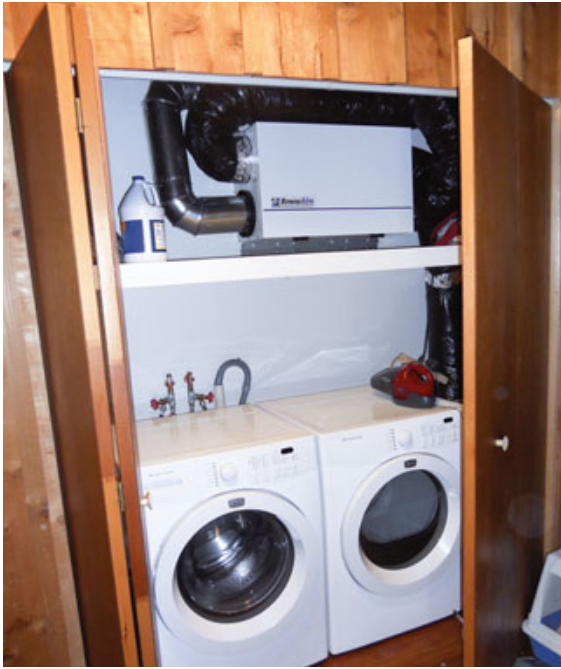
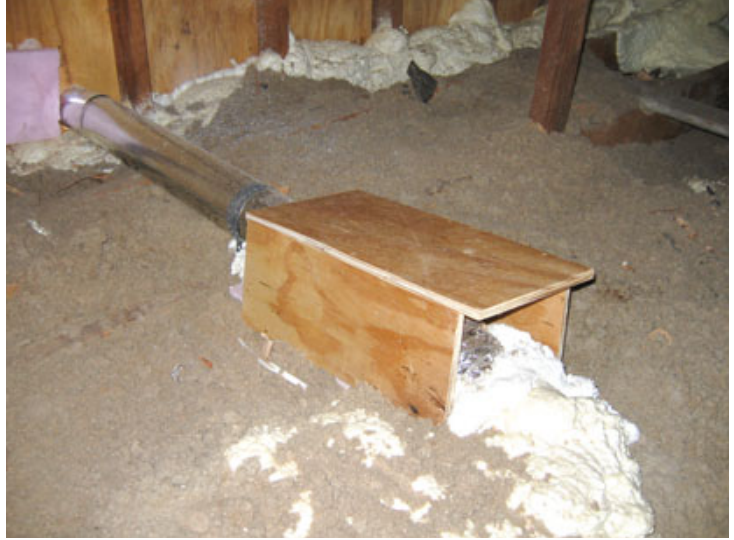
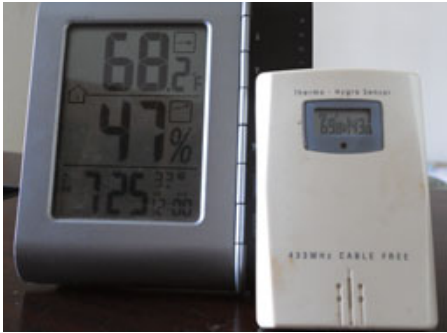
Figure 10. The ERV that supplies the tight retrofitted house with fresh air (above left) is installed at head height in an often-used area, making filter changes easy. The ceiling opening where the flex duct from the new bathroom fan transitions to rigid duct in the attic was enclosed in a plywood box and sprayed with foam for air-sealing and protection from foot traffic (above). The thin, uneven layer of rock wool covering the floor was later covered with 18 inches of loose-fill cellulose. An inexpensive combination thermometer-hygrometer (left) makes it easy to keep an eye on temperature and humidity in several locations, indoor and out.

We replaced the old, inefficient (and unsafe) water heater with a Takagi T-K3 sealed-combustion demand heater. The new RenewAire EV 130 ERV was installed on a conveniently located shelf in the closet that houses the clothes washer and dryer (Figure 10). It draws supply air through a vent high in a sidewall and exhausts the outgoing air through a run of rigid duct that exits low in the wall, thus avoiding penetrations into the attic. The loud old bath fan was replaced with a Panasonic WhisperLite and the old, non-functional range hood replaced with one that works.

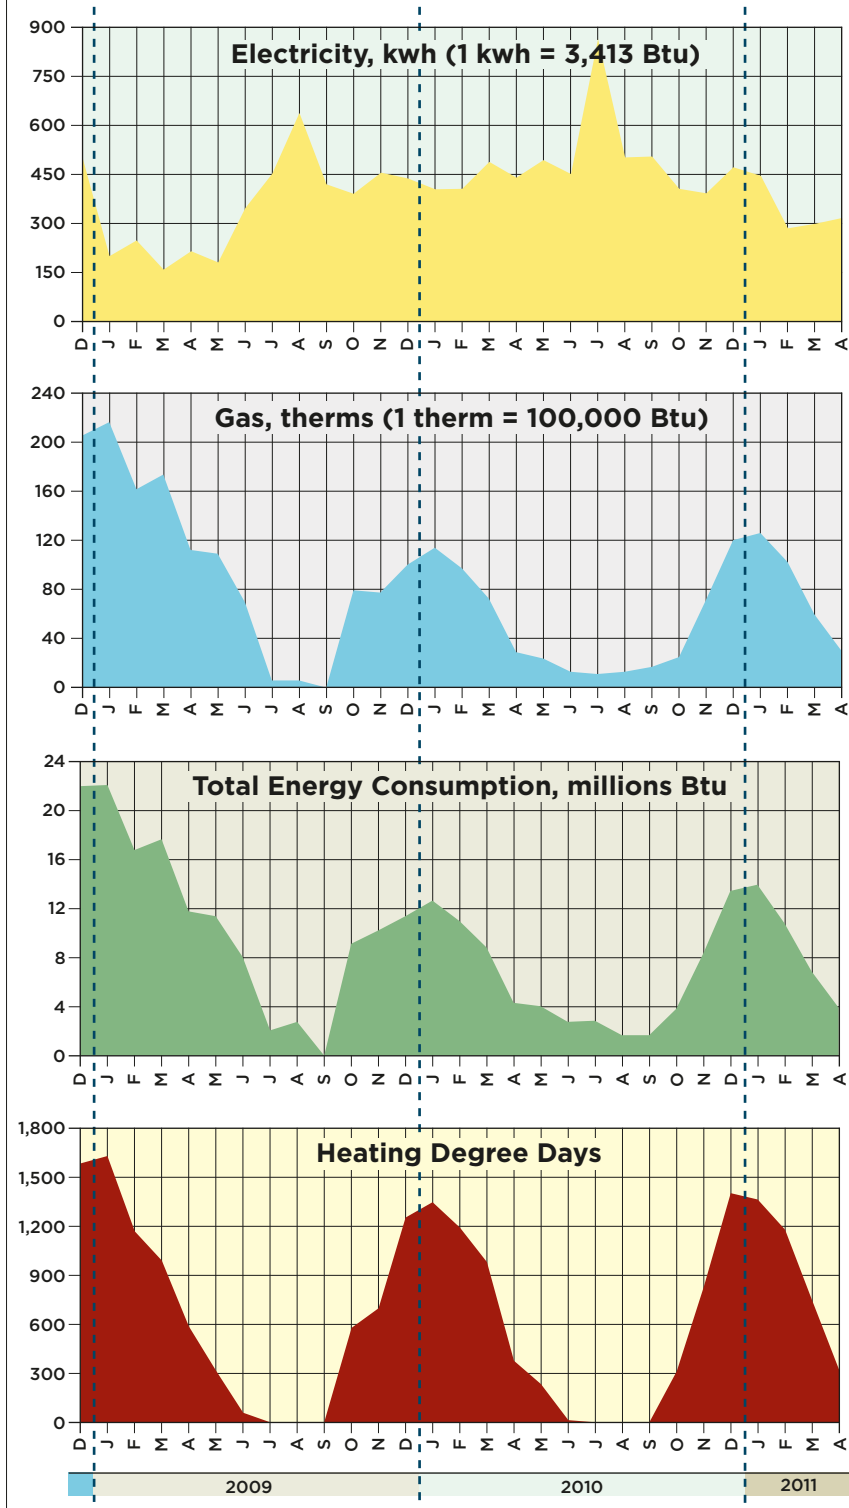
Unexpected result. As Figure 11 shows, overall energy as measured in MMBtu — a unit that makes it possible to express gas and electric use as a single number — declined sharply. That's consistent with the improved insulation and tighter building envelope, and it's quite close to the pre-project projection based on the REM/Rate energy modeling program. But even a small house is a complex system, and changes in one area can have unexpected results in another. Soon after the completion of the initial phase,

Figure 11. While natural-gas consumption was dramatically reduced as a result of tightening the house, electrical consumption did not follow the same curve. This was at least partly due to unforeseen moisture buildup in the home, which necessitated the use of a basement dehumidifier — thus the spike in electrical use in July 2010. Basement moisture will be dealt with in the second phase of the project.

the indoor humidity began to rise as a result of reduced air leakage and a relatively high water table around the original basement.

That problem will be dealt with permanently during Phase 2 of the project, along with the minimal headroom, absence of insulation, and elevated radon level. For now, though, the indoor humidity is being kept under control with a dehumidifier. As a result, post-retrofit electricity consumption has remained about what it was before the work began, offsetting the gains made by changing incandescent lights to CFLs and installing new energy-efficient appliances.
