Hidden Defects Complicate a Simple Deck Replacement

BY MIKE WHALEN

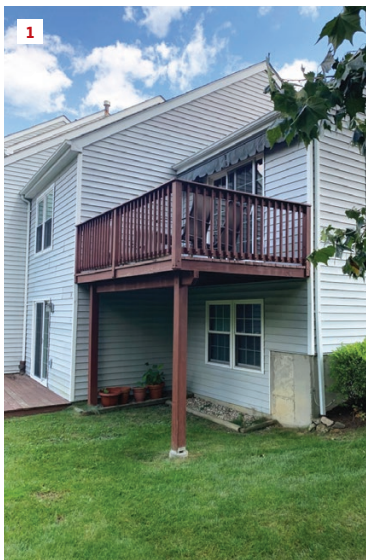
In late 2020, my company was approached by a client who wanted to replace a small deck on the condo she had recently purchased. Measuring roughly 12 feet square and framed with pressure treated 2x8 joists with 2x6 PT decking, the deck had been built in the 1990s at the same time as her home, the end unit of a four-unit townhouse that's part of a 100-plus-unit condo development. Even after 25-plus years of service, the deck seemed structurally fine, but the owner wasn't happy with the 8-inch step up from the deck to floor level **(1)**.

While the existing deck displayed no outward signs of instability **(1)**, the ledgers had not been properly flashed and the underlying OSB sheathing was revealed to be water damaged upon removal **(2)**.

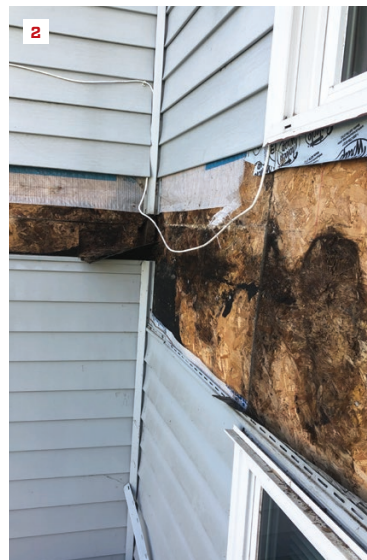
When we began to demo the deck the following spring, we discovered that the deck's two ledgers had not been flashed properly. The home's vinyl siding was butted against the top of the decking on both the eaves and adjacent end walls, concealing that the deck-to-wall flashing was missing. The housewrap was just lapped over a narrow strip of building paper that had been tacked in place behind the ledger, with the top edge of the paper aligned with the top of the deck.

The outward appearance of the ledger connection seemed OK—the deck wasn't too wobbly—but when we removed the ledgers, we found that the OSB sheathing underneath was in bad shape **(2)**. The more vinyl siding we removed below the deck, the more rotted OSB we found, particularly on the condo's end wall **(3)**.

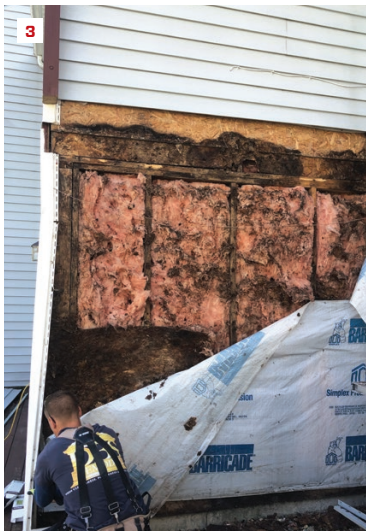
With little to no overhang and more surface area than the eaves wall, the end wall was more vulnerable to water damage from wind-driven rain. Compounding matters, the woven-type housewrap beneath the vinyl leaked like a sieve at various times and in different locations along this critical juncture.

The end-wall sheathing was severely deteriorated **(3)**, and removing the water-damaged materials revealed that the floor framing had been installed without rim boards; a square hole (top right in photo) was cut into the outboard I-joist to verify floor framing direction **(4)**.

and inspected the interior of the home for signs of water damage and mold and found none. After removing all the rotted OSB sheathing (the bulk of which was from the end wall) and fiberglass batt insulation, we found that the underlying framing was in fairly good shape. So we applied a mold-inhibitor onto the affected areas, sistered a few new studs onto the studwall, and left the exposed stud bays open overnight and into the next day. Because it was early spring and still cold, we had to balance wanting to dry out the wall cavity and quickly buttoning everything up for heating purposes.

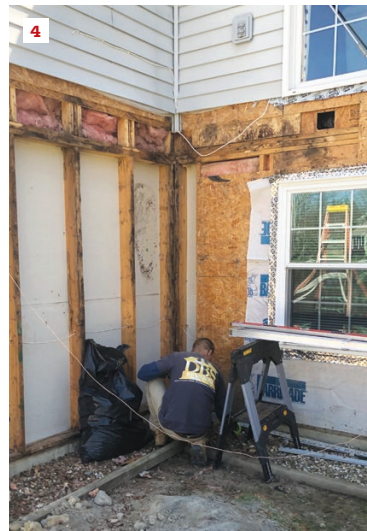
No rim boards. Another hidden surprise was the floor system, which was framed without rim boards. When we removed the end wall's damaged OSB, the ends of the wood I-joists were just staring us in the face **(4)**. These 12-inch-deep I-joists run perpendicular to the end wall and parallel to the eaves wall, with 2x4 squash blocks run vertically on either side of the joists.

Along the end wall, the original builders had lag-screwed the ledger to the squash blocks, as well as to the wall's double top plate. On the eaves wall, where the outer I-joist "rim board" offered little help in terms of ledger fastening, the 2x8 ledger was only lagged at the double top plate. I sent pictures of our findings to an architect we frequently work with, and he was stunned.

A structural redesign. The architect sent us a couple of ledger attachment scenarios for the planned deck: lagging the 2-by PT ledger to the existing house framing with staggered LedgerLok screws 6 inches on-center if the I-joists ran perpendicular to the eaves wall; or, if the I-joists ran parallel, installing four hold-down devices attached to joists with 1/2-inch-diameter threaded rod with nuts and washers. To see which scenario would apply, we cut a roughly 6x6 square into the web of the outboard I-joist running parallel to the wall, confirming that the floor joists were indeed parallel to the eaves wall.

In lieu of removing interior drywall to block out five joist bays for the hold-downs and threaded rod, we opted to build a less-invasive, free-standing deck. This decision was also prompted by the client's desire to raise the deck elevation to decrease the step down from the sliding door from 8 to 4 inches, which would have made securing a new load-supporting ledger along the eaves wall all the more difficult.

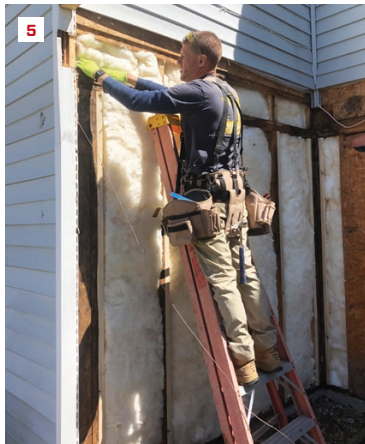
After re-insulating (5) and resheathing the walls, workers installed a peel-and-stick membrane in the ledger area (6), running the membrane 6 inches above the new deck elevation and behind the WRB.

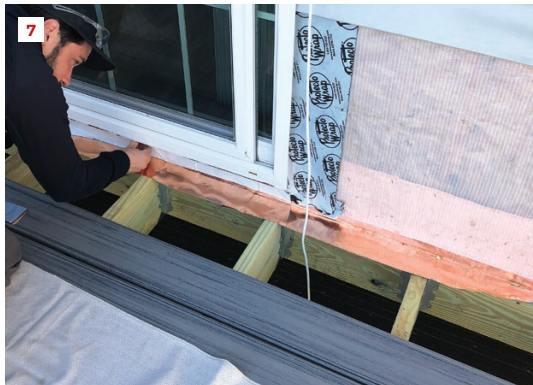
L-shaped copper flashing (yorkflashings.com) is installed on top of the ledger along the deck-to wall juncture. The new deck was raised 4 inches to decrease the step down from the sliding door (7).

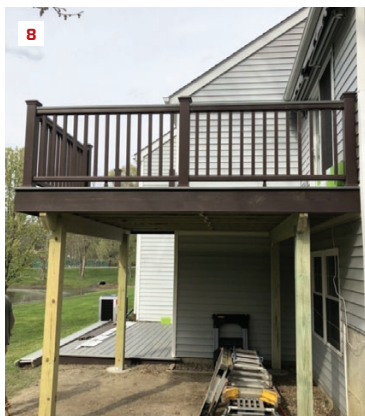
The free-standing deck is supported by a pair of double PT 2x12 drop beams and four 6x6 posts (8). While the condo association approved the new Trex composite decking, the posts and railings needed to be dark brown to match the original deck (9).

The new deck matches the original deck's footprint, but we increased the joist size to 2x10 stock, which helped with the ledger attachment issues to the house. At either end of the deck, we supported the joists with a pair of double PT 2x12 drop beams, which in turn are supported by four 6x6 posts on 18-inch-diameter by 48-inch-deep concrete piers. For lateral stability, we fastened the two 2x10 ledgers to the house framing with LedgerLok screws 16 inches on-center in a staggered pattern where feasible. At the eaves wall, the flush-framed joists are secured to the ledger with hangers.
