I N S T A L L I N G

Water-Managed

Synthetic

Stucco

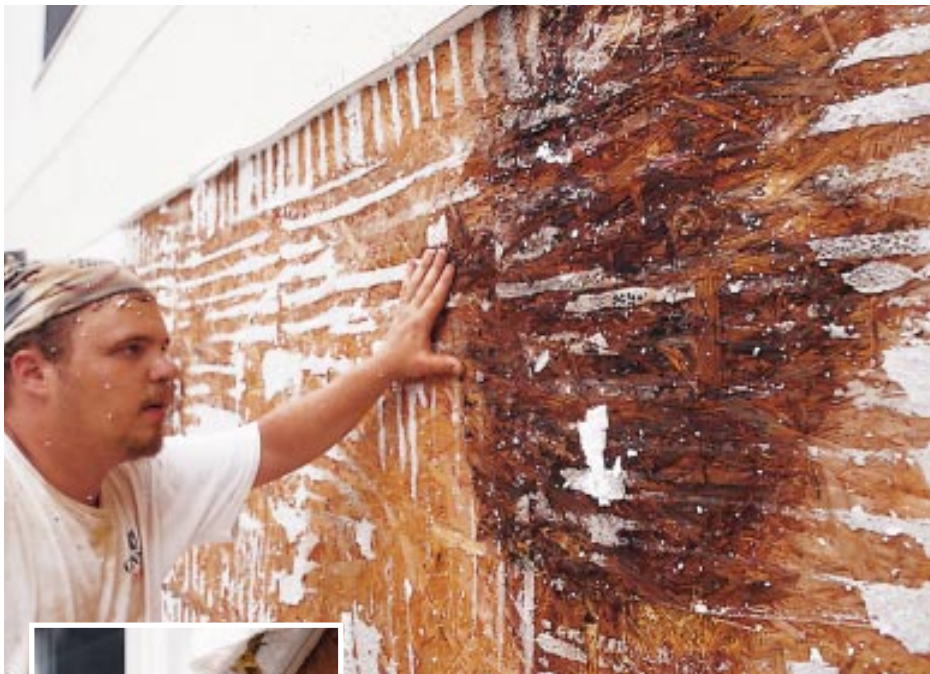
Figure 2. This three-year-old Greensboro, N.C., home was damaged when water leaks around windows and poorly-flashed roof-wall connections became trapped behind the EIFS cladding (above). Even window trim, jambs, and sills were rotted (inset) and had to be replaced.

One of the tear-off and replacement jobs I recently completed was on a 7,000-square-foot home in an upscale subdivision of Greensboro, N.C. The \$1.7 million home was only three years old when the owners discovered extensive water damage behind the barrier EIFS exterior (Figure 2).

Whole sections of the OSB sheathing were blackened and rotting. Both the sheathing and the fiberglass insulation in the wall cavities were still wet and moldy. Most of the home’s 40-plus windows had rotting sills and mullions — in fact, mushrooms were growing out of some of the sills. We discovered a colony of carpenter ants in the structure, and shelf fungi were growing inside the wall cavities. The home required the replacement of all windows, all the OSB sheathing and insulation, some door frames, much flashing, and many of the studs, as well as the entire barrier EIFS stucco system.

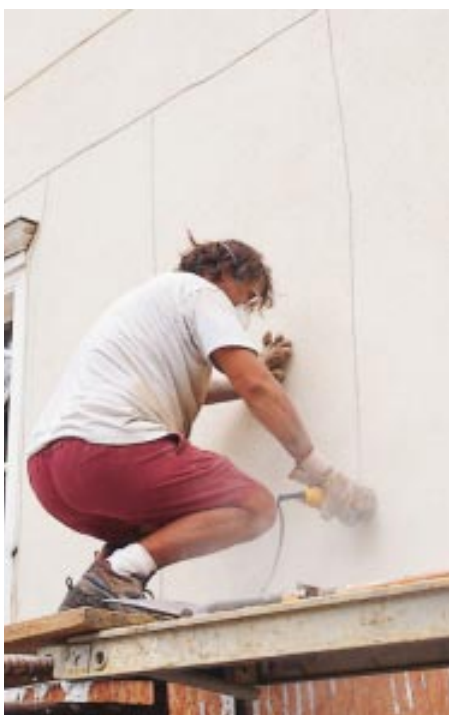
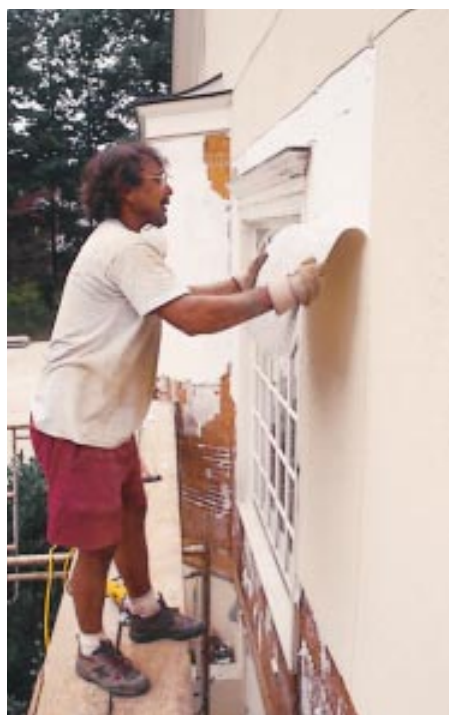
Figure 3. To remove the EIFS cladding, the author’s crew first cuts 1/4-inch-deep kerfs in the stucco skin, using a 4-inch masonry grinding wheel (left). The 3x5-foot sections or “skins” are then peeled away, exposing the underlying foam (right).

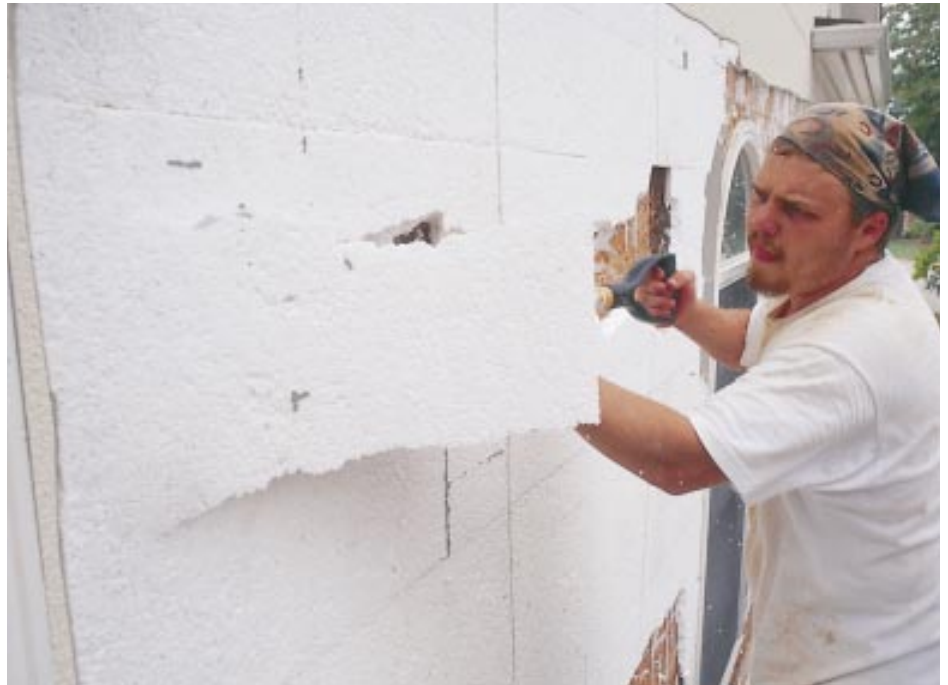
Figure 4. Large sections of foam are pried off with flat-faced shovels; smaller pieces and detailing are removed with spatulas or trowels. A crew is stationed on the ground during tear-off to clean up.

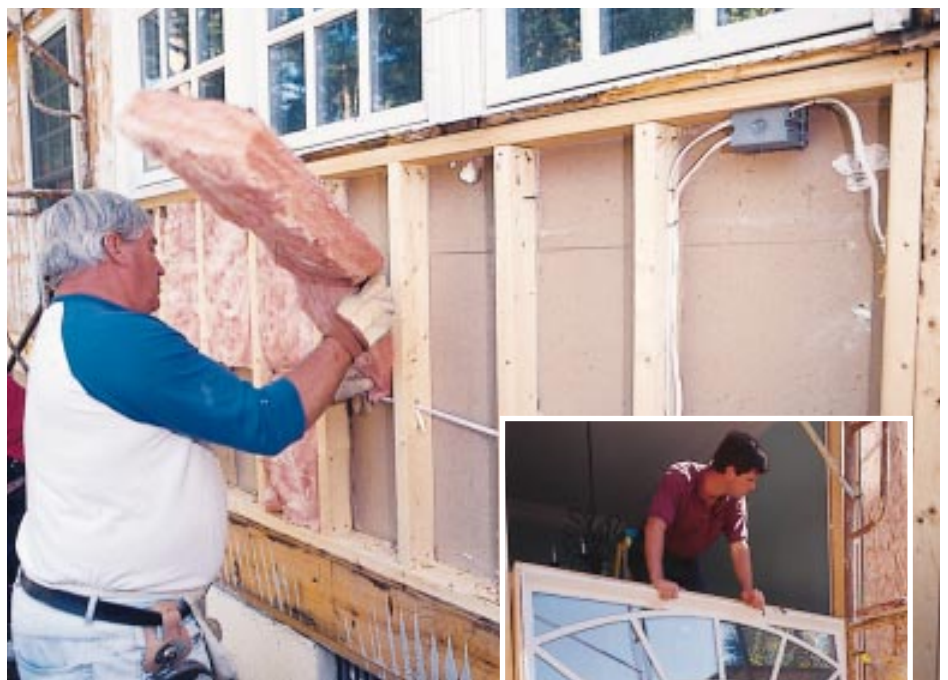
With the sheathing removed, we can see any additional water damage that we missed during the initial search. On this house, the south wall (which faced the street) was in worse shape than we thought. The whole wall was rotted and had to be reframed, reinsulated, and resheathed, and all of the windows and doors had to be replaced (Figure 5). The source of the leak appeared to be missing copper kick-out flashings at roof/sidewall junctions, which we installed (Figure 6, next page).

Figure 5. Hidden damage to the structure was discovered during tear-off on the south wall. The wall had to be torn out and replaced, including wiring and insulation (left), and doors and windows (right).

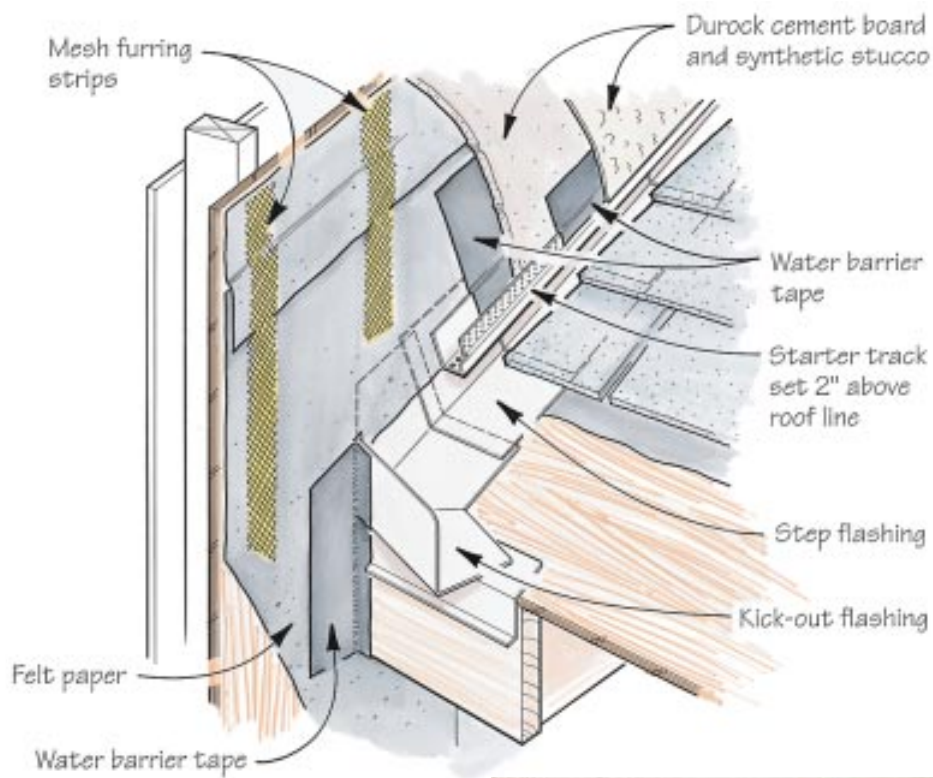
Kickout Flashing

Figure 6. Missing kick-out flashings at roof-wall junctions are a common source of leaks in EIFS failures. The author prefers a heavy-gauge copper for these flashings.
