# MOISTURE PROBLEMS: FIVE CASE STUDIES

*Understand the mysteries of moisture,  
or your buildings may suffer the consequences*

by William Lotz

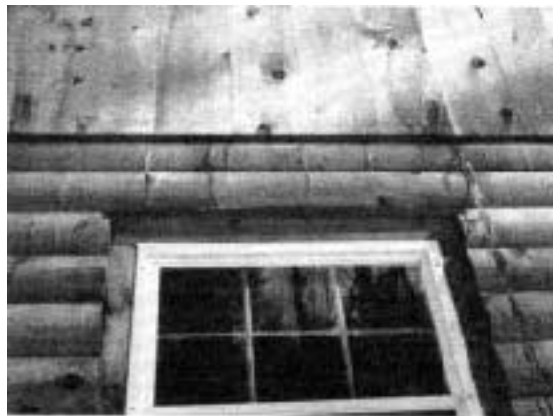
## Vapor Barriers

This New Hampshire house was a year old when I saw it. The main level was log cabin construction but the second-story wall was framed. From the inside out, the upper-story wall consisted of v-groove 1x6 pine boards, unfaced 6-inch fiberglass, 4-mil poly, and vertical T&G plank siding. There was water damage everywhere. Ice ran down the exterior of the logs (see photo, top right). The contractor was obviously confused about the vapor barrier, which he installed on the cold side of the wall, rather than the warm side where it belonged. He also made the error of installing a recirculating kitchen fan over the gas stove and no exhaust fan in the main-floor bath. The second-floor bath fan vented into the attic (against the law in many states). Added to this was a basement water problem. The house is now being torn apart and rebuilt. I hope the contractor has good insurance coverage.

High moisture levels and a wrong-side vapor barrier ruined this year-old home. Note the ice running down the logs.

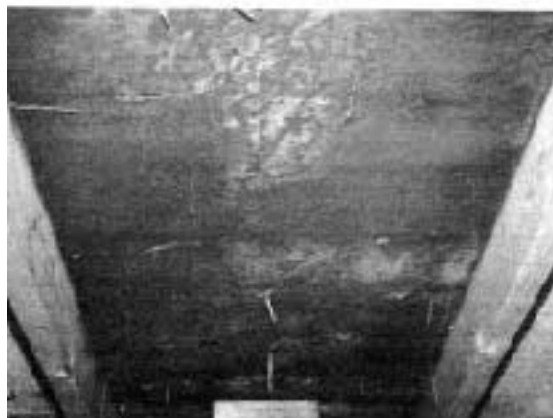
## Rain from the Ceiling

This factory-built house was on the Massachusetts-New Hampshire border. The photo at right (middle) shows the black mold and mildew that resulted from one year of venting a kitchen exhaust fan into the eaves above the soffit. The prevailing winds blew the moisture back up into the attic space. The water dripped down into the fiberglass and damaged the drywall ceiling. The fan should have been ducted to a point outside the house, not into the eaves.

The plywood roof sheathing turned black from moisture. The source: a kitchen fan exhausted in the eaves.

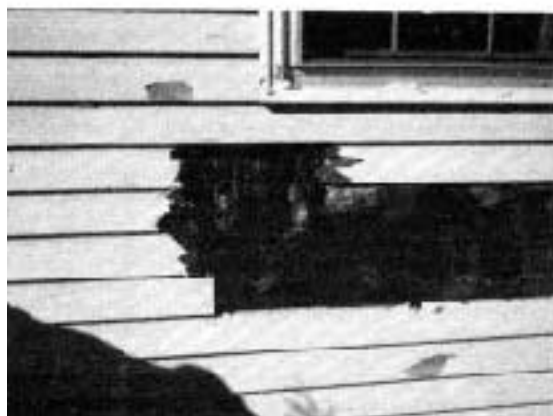
## Cape Cover-up

A family bought this house in June; it had a nice new yellow paint job on the clapboards. By fall, the paint was peeling and it was evident that the new paint covered up severe wall rot (photo, bottom right). For years, the previous owner had stored many cords of

green firewood in the basement. Not only was there no exhaust fan, but the dryer was vented into the basement. The wall had a poly vapor barrier, but it was full of holes as the result of a sloppy installation.

Due to moisture damage in the walls, the house required a major rebuild. The new owner filed suit against the former owner for trying to cover up the moisture problem. Someone had installed small, round aluminum vents in the stud spaces in an attempt to solve the problem. The vents didn't help with the moisture, but only lowered the thermal value of the fiberglass insulation.

Firewood stored in the basement contributed to rotted sheathing and studs.

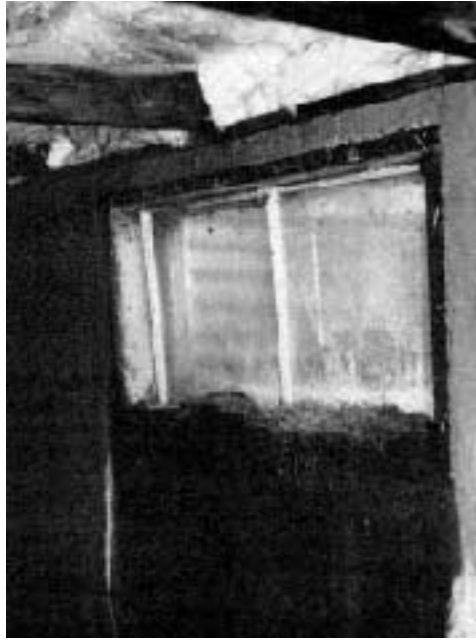
### Crawlspace Swimming Pool

I don't like crawlspace foundations. Here's a classic example of how they can fail. These buildings were built to U.S. Government specs for low-income housing. The architect's design included crawlspaces under each building. The builder put poly on the ground, but it had no value because the water table was *above* the poly!

After seven years, many of the floor joists had to be replaced because they had turned to black mush (see photo, right). Fortunately the house was built with a poly vapor barrier in the walls and ceiling, so damage to the rest of the building was limited.

*Plastic sheeting on a crawlspace floor doesn't help when it's under water. The results: rotted 2x12s, a rusty window frame, and moss growing in the window sill.*

To repair the crawlspace area, we needed sump pumps and a carefully installed concrete floor. The slab had to be reinforced and structurally connected to the foundation walls and columns. We also upgraded all of the bathroom exhaust fans and wired them through the light switch (rather than a separate switch).
