Making the Most of a Siding Replacement Job

A re-siding project offers a rare opportunity to upgrade a home's air-sealing and insulation

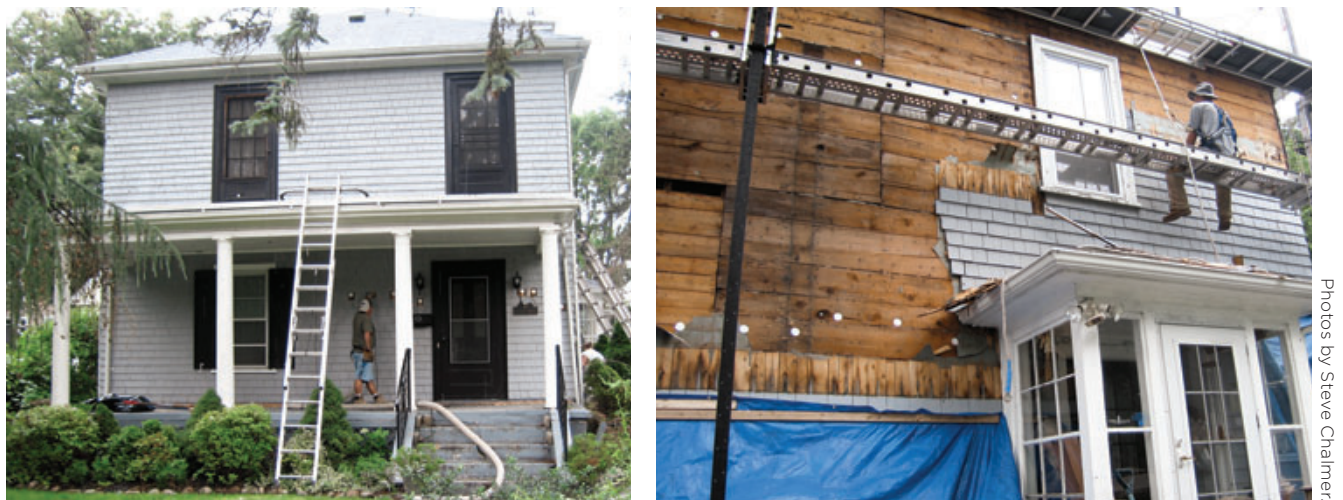
Figure 2. The wall cavities were first dense-packed from the outside with blown cellulose insulation (left). Then the crew stripped off the old cedar shingle siding, focusing on one side of the house at a time to protect the exposed walls and insulation from the weather (right).

Our insulation sub installed the cellulose at a density of at least 3.5 pounds per cubic foot, giving the walls a solid R-13 or more worth of insulation (**Figure 2**). Though not technically an air barrier, dense-pack cellulose reduces air movement both through and within the wall, which gave us a good head start at air-sealing. After the cellulose was installed, we performed another blower-door test and found that we'd decreased the air-leakage rate to 2,550 cfm50, or about seven air changes per hour. (This wasn't tight enough to

In some areas — such as below windows or where there was blocking — we discovered voids in the cellulose as we stripped off the shingles. In those places we pulled off the exterior 1x12 board sheathing and insulated with fiberglass batts. This was faster and more cost-effective than calling back the insulation sub, especially since

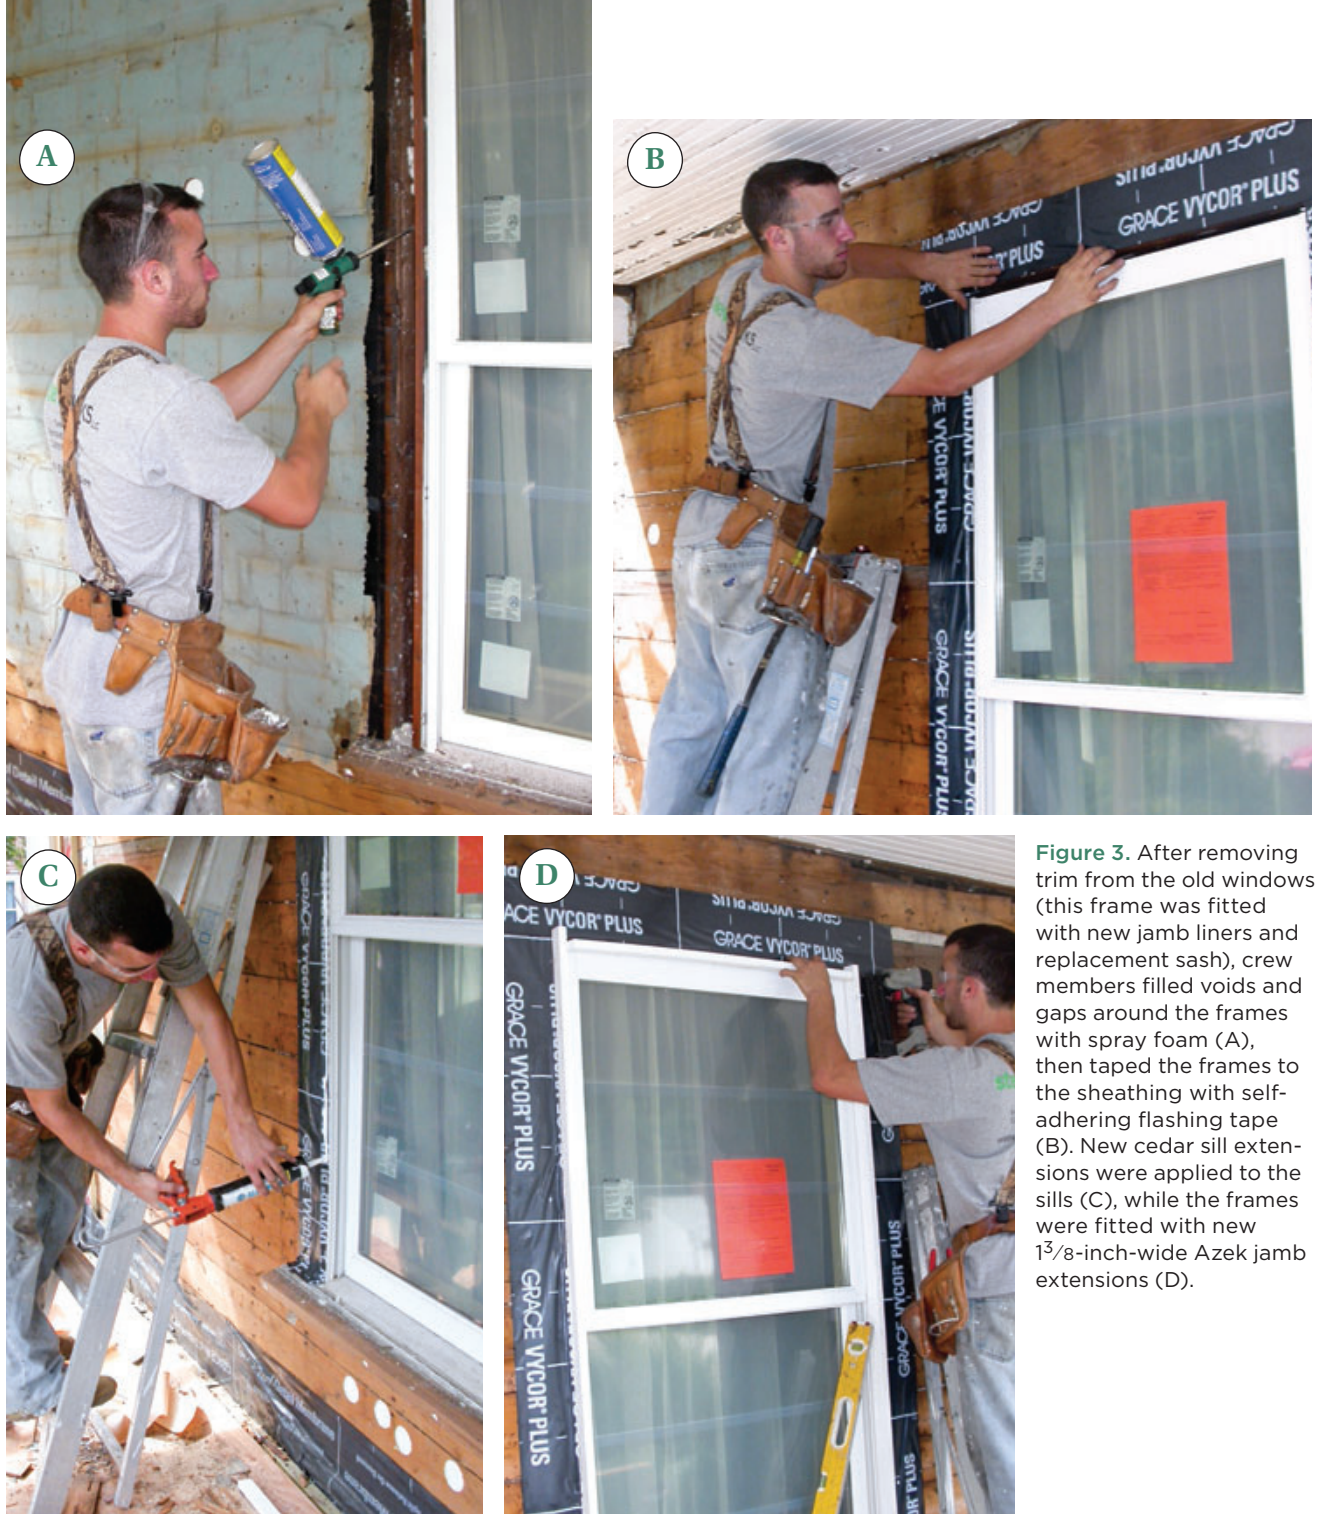
Figure 3. After removing trim from the old windows (this frame was fitted with new jamb liners and replacement sash), crew members filled voids and gaps around the frames with spray foam (A), then taped the frames to the sheathing with self-adhering flashing tape (B). New cedar sill extensions were applied to the sills (C), while the frames were fitted with new 1³/₈-inch-wide Azek jamb extensions (D).

We filled small voids around the windows — like unneeded sash weight pockets — with spray foam (Figure 3, page 3). Then we sealed the window frames to the 1x12 sheathing with 4-inch-wide Grace Vycor window flashing (866/333-3726, na.graceconstruction.com), taping the bottoms and legs first. When we taped across the tops of any windows that were exposed to weather, we used wider 6-inch Vycor and left a 2-inch flap (with the release paper backing still attached) hanging down over the head jamb. Later, when we fastened the jamb extensions to the frames, we folded these flaps back, peeled off the remaining release paper, and attached the flashing to the extension. The flaps act as sheathing-level drip caps that keep water out of the joints between the jamb extensions and head jambs.

We ripped jamb extensions from Azek, a low-maintenance cellular PVC product (877/275-2935, azek.com), making them 1³/₈ inches wide to accommodate the

1-inch-thick rigid foam and ³/₈-inch-thick plywood rainscreen battens that would be added to the wall. We fastened the extensions to the jambs with 2¹/₂-inch trim nails and welded their corners together with PVC glue.

The sill extensions were ripped from 2x4 cedar. We beveled them to match the angle of the existing sills and made a shallow relief cut on the underside to serve as a drip edge. Then, after applying exterior carpenter's glue, we fastened them to the sills with 3-inch-long screws driven through predrilled countersunk holes. We filled the holes with Abatron two-part epoxy putty (800/445-1754, abatron.com).

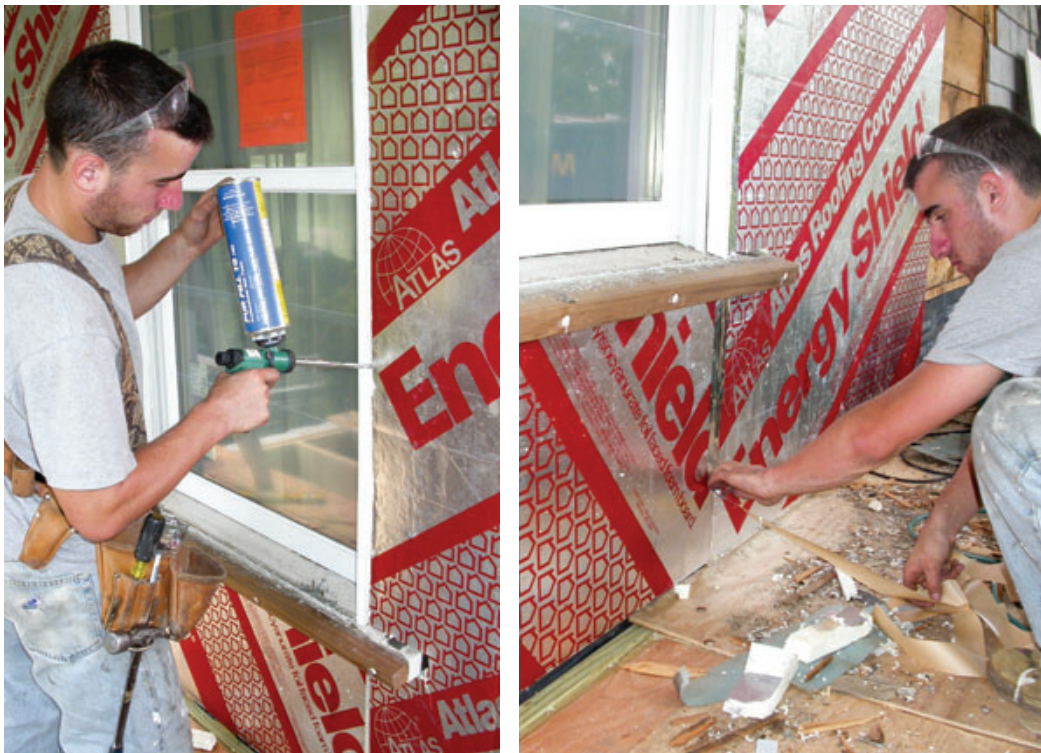
Figure 4. The walls were wrapped with 1-inch-thick sheets of polyisocyanurate foam, which adds R-6 to the wall assembly and acts as an air and vapor barrier and drainage plane. All joints — including gaps between the rigid foam and jamb extensions — were foamed (far left) and sealed with flashing tape (left).

In this wall assembly, the rigid foam acts as the air and vapor barrier and as the drainage plane, so we took pains to seal the joints carefully. First, we filled in the nooks and crannies and quick-cuts with spray foam (Figure 4). Then we taped all of the seams with Atlas WRB flashing tape to continue the air-seal.

we could. We filled any gaps between the jamb extensions and rigid foam with spray foam, then covered the joints with flashing tape.

At the corners, we taped the sheathing with Vycor before installing the rigid foam, then taped the joints afterward. We also wrapped the exposed bottoms and edges of the sheets with tape (pulling the tape from the back to the front), which should help keep insects from burrowing into the foam.

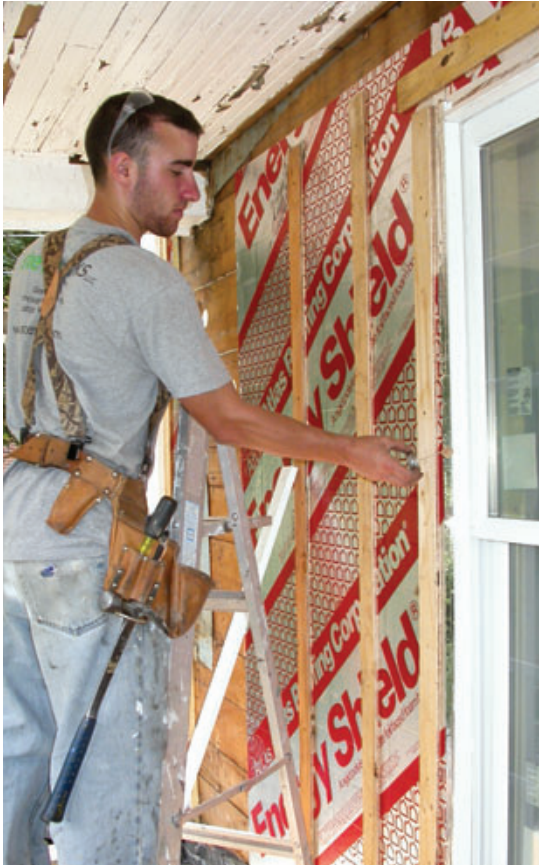
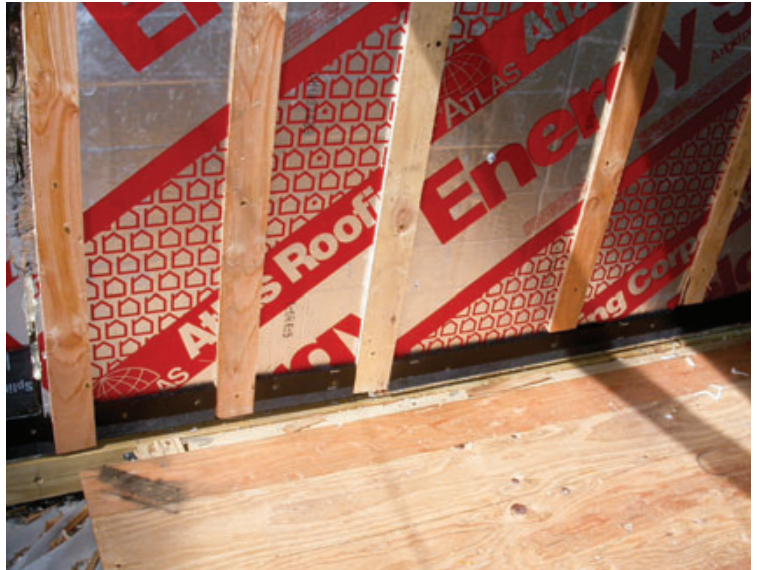
Figure 5. Battens ripped from $\frac{3}{8}$ -inch plywood were fastened through the foam and sheathing into the wall framing to provide solid nailing for the fiber-cement siding and create a drying airspace behind it (left). Strips of $\frac{3}{8}$ -inch-thick Cor-A-Vent installed along the base of the wall between the battens keep out insects (above).

We ripped strips of $\frac{3}{8}$ -inch PT plywood to use as rainscreen battens (**Figure 5**). Not only will this drying space behind the siding add several years to the paint job, but it allowed us to put up siding during one of the rainiest Junes on record without worrying about trapping moisture underneath.

We located the battens over wall studs and filled the gaps between them along the bottom edge of the house with Cor-A-Vent siding vents (800/837-8368, cor-a-vent.com). The screened vents prevent insects from nesting behind the siding while allowing moisture to drain and air to circulate.

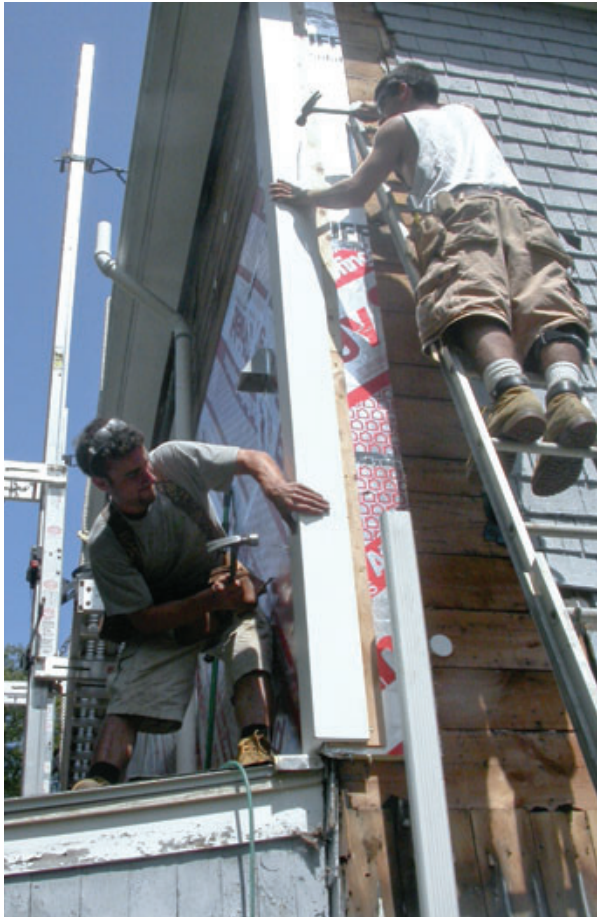
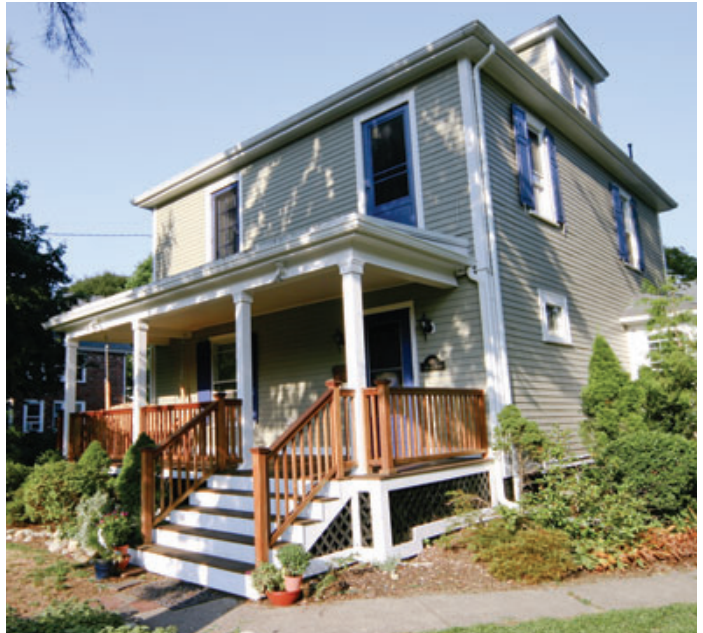
Figure 6. Workers trimmed the corners with one-piece Azek PVC corner boards (left). To reduce maintenance costs, the homeowners opted to replace the weathered cedar shingles with new factory-painted fiber-cement lap siding (above).

Though we repaired a few rotted windows with epoxy, we replaced most of the window and door casings with 1x5 Azek PVC trim. At the corners, we installed one-piece Azek 5/4x6x6 corner boards, which should do a better job of blocking water than the 5/4x6 fiber-cement trim boards we've used in the past (**Figure 6, page 6**). Besides being very heavy and tough to work with, fiber-cement trim boards have milled edges that make it tough to close up the butt joints on corner boards.

Finally, we installed 5 $\frac{1}{4}$ -inch HardiePlank fiber-cement siding with a 4-inch exposure. With a single coat of factory-applied paint, HardiePlank has a 15-year finish warranty (a second coat extends the warranty to 25 years). We nailed the siding
