## Refinishing a Brownstone Stoop

I've written a number of articles for *JLC* on renovating Hoboken, N.J., row houses. One topic I haven't discussed but that's often part of our scope of work is refinishing a home's entry stoop.

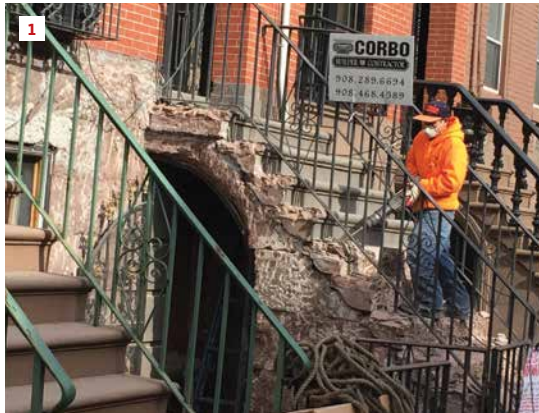
The typical stoop on a brownstone row house was built with an open stringer. Here, a worker begins a repair by chipping off all of its brownstone finish with a rotary hammer (1). Some stairs were designed with closed stringers composed of a brick and brownstone mixture (2).

At the start of the job, Bezama's crew begins by chipping away 1/2 to 3/4 inch of the stoop's surface down to solid brownstone with rotary hammers (see photo 1, previous page). They also chip away the garden-level façade's veneer; roughing up the surface to promote the bonding of what I call the "restoration" coat.

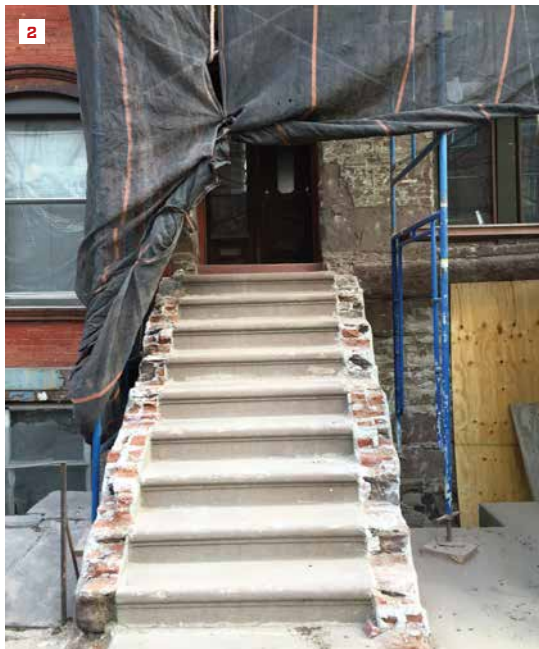
Entry stoops in Hoboken were traditionally made mainly from New Jersey brownstone. They were commonly built as open-stringer stairs (1), but occasionally have closed stringers composed of a mix of brownstone and brick (2). Extracted from nearby quarries around the turn of the century (most of Hoboken's row houses were built between 1880 and 1900), brownstone—a type of sandstone—was an inexpensive substitute for marble and limestone. The growing urban middle class at the time could afford something a little more architecturally sophisticated than the usual brick façade, and brownstone offered a reasonable upgrade—it was easy to cut, carve, and transport.

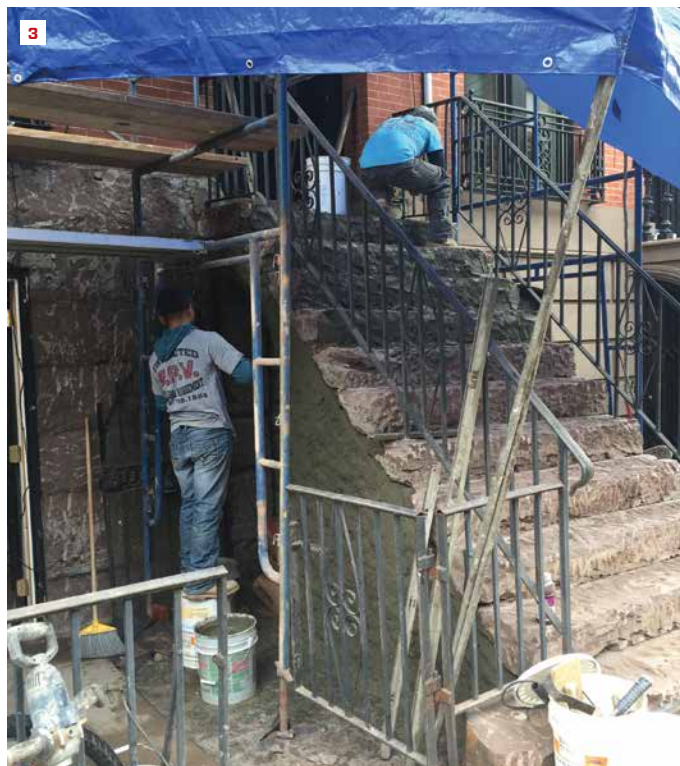
With the chipping complete (3), the demoed surface gets pressure-washed to remove dust and debris. Bezama's crew lets the surface dry before using a fast-setting cement-based repair mortar called MasterEmaco N 424 ([master-builders-solutions.basf.us](http://master-builders-solutions.basf.us)) for the restoration coat. They mix this repair mortar with water (it comes as powder in 5-gallon buckets) until it reaches the consistency of damp beach sand—and only as much material as they can install without it prematurely setting up. Working from the top down, they lightly wet the work area to a saturated-surface-dry standard and apply a thin bond coat, consisting of a diluted mix of the repair mortar.

Modern repair of a brownstone finish relies on three-coat concrete stucco—a more durable material than the traditional sandstone. After the old material is chipped off, reducing the stairs to a rounded but stable substrate, the repair crew builds back the stairs using a "restoration coat" of a fast-setting cement mortar. With little more than trowels and straightedges, the skilled crew sculpts a new set of stairs from a well-compacted build-up of the repair mortar.

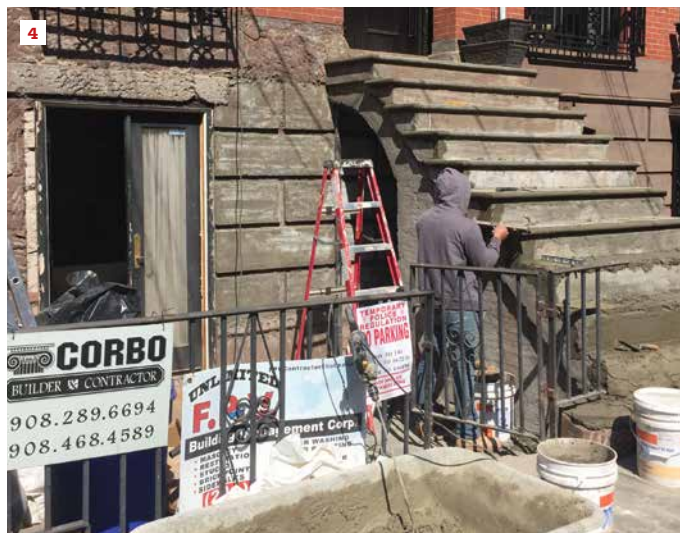
I'm always amazed by the skill Bezama's crew exhibits at this stage—they basically sculpt out the stairs using only trowels and hand levels (4). They're able to precisely recreate the stair's bullnose and scotia molding on each tread, while maintaining riser-height and tread-depth uniformity, and providing a 1/8-inch-per-foot slope on the treads and landing for drainage. On the adjacent façade, they make the linear lines simulating brownstone blockwork with longer, 4-foot levels. The ability to shave the Matrix mortar allows them to create sharp edges on these faux-blockwork lines. When they've formed the entry stoop (and adjacent façade), they let it cure, then apply the scratch coat.

The crew applies the repair mortar in firm, 1/8- to 1-inch lifts to get good compaction, building out the material beyond what's needed. After a few hours, they "shave" off the semi-dry excess material, a little bit at a time, to the desired profile. The shaved waste falls off like grains of sand and is considered dead material that can't be re-used.

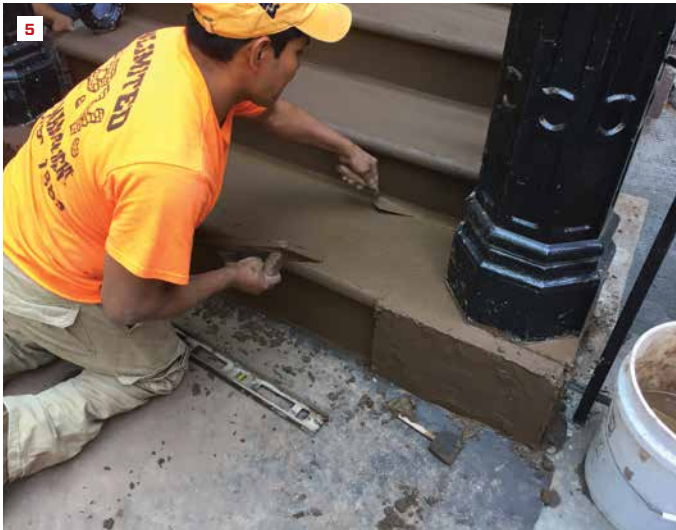
The finish coat—a color-tinted cement-based mortar—goes over the scratch coat and is finished with trowels, levels, and sponges (5). Ironwork is an important but extremely expensive part of a stoop repair. Usually, the old ironwork is salvaged with wire brushes and new paint, but occasionally the author has a chance to replace it entirely to good effect (6). When cured, the finish coat needs to be power-washed with a weak solution of muriatic acid to even out the color (7).

For the finish coat, the crew uses a cement-based repair mortar called Matrix ([conproco.com/matrix](http://conproco.com/matrix)) that's color-matched to the brownstone and is mixed and applied similarly to the MasterEmaco N 424 repair mortar. They apply it 1/4 inch thick, using trowels, levels, and sponges (5). After this top coat dries, they power-wash it with a weak solution of water and muriatic acid as needed to achieve a uniform color (7).

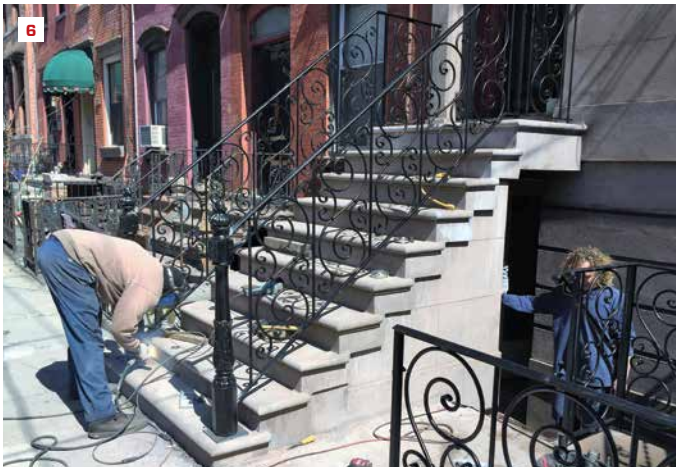
When the budget allows, new railings and guards look awesome (6). We work with Joe Monga, of Decorative Ironworks, in Paterson, N.J. He has catalogs and pictures of different styles that clients pore over, but we often have to rein them in; newel posts alone can cost \$8,000 apiece.

Decorative railings can be a real budget buster; I've gotten quotes up to \$40,000 for a stoop's wrought-iron work alone. We try to re-use the existing railings as much as possible, simply removing and storing them during the job, then reinstalling and painting them in place. However, on some jobs, we've needed to have them sandblasted, primed, and painted off site.
