## Reinforcing a Bulging Foundation

## A Cure for a Bulging Foundation

BY JAKE LEWANDOWSKI

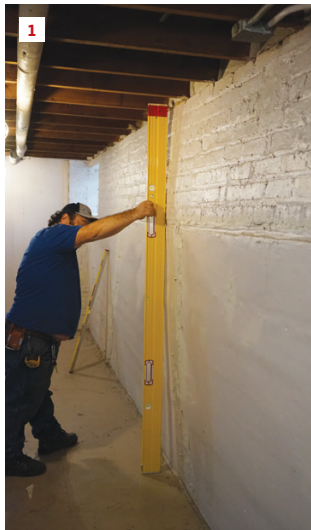
The poured foundation was solid, but over time, one wall had rotated inward more than 3 inches at its maximum (1, 2). In plan, the foundation was plumb at the corners and bowed in at the middle. To stabilize the foundation wall, we installed six vertical I-beams, anchored in concrete footings at the base and bolted to the first-floor framing above (see Reinforcing a Bulging Foundation, left, and photos on pages 14 and 15). After securing the I-beams in place, we filled the tapered gaps between them and the existing wall with high-strength structural mortar.

This foundation had rotated inward considerably, and the resulting bulge was visible from both the interior (1) and the exterior (2). The solution, shown in the illustration, was to install a series of six vertical steel I-beams—anchored in concrete below and attached to the floor framing above—to resist any further lateral movement.

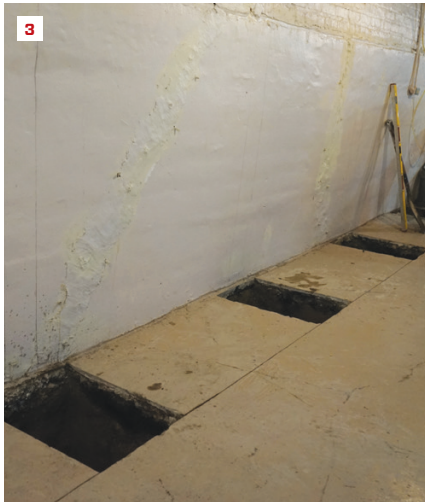
The crew laid out the positions of the vertical beams on the basement walls (3). After snapping a line across the slab and scoring it with a saw, they removed rectangular sections of the existing slab and dug holes for the beam footings. They then ground the paint off the foundation wall at each beam location (4). The beam footing holes were 24 inches deep and extended 18 inches from the foundation wall (5).

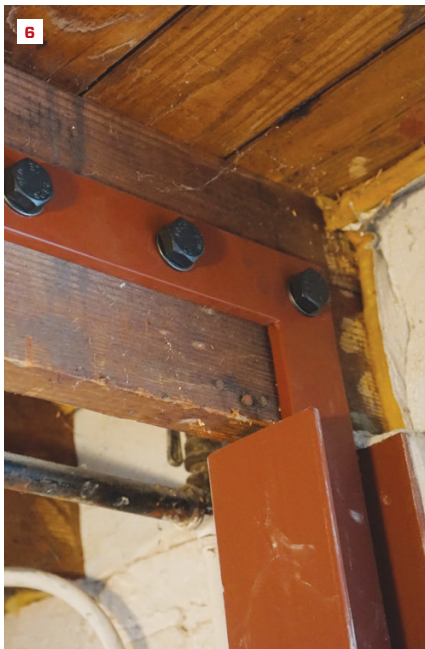
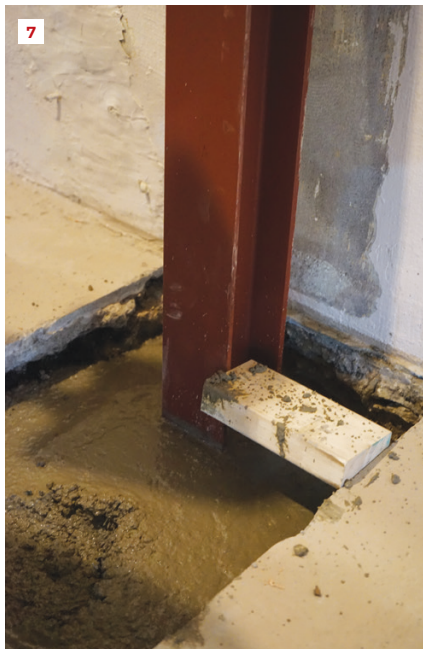
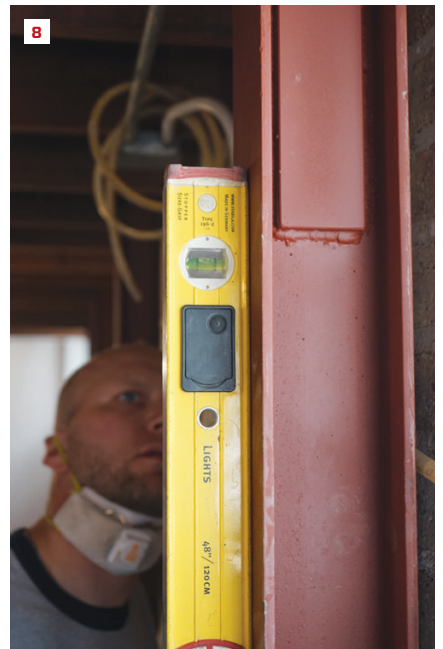
Next, the crew placed each beam in its footing hole on a temporary block that set the beam 6 inches from the bottom of the hole. They rough-plumbed the beam with one flange touching the bulging wall. A flat L-bracket had been welded at the top of each beam with  $\frac{3}{4}$ -inch holes as specified by the engineer. They drilled through the joists and drove high-strength  $\frac{3}{4}$ -inch bolts at each hole location (6). After removing the 6-inch block and leaving the beam temporarily suspended from the joist, they poured concrete to within 4 inches of the top of the slab (7) and gave each beam a final check for plumb (8).

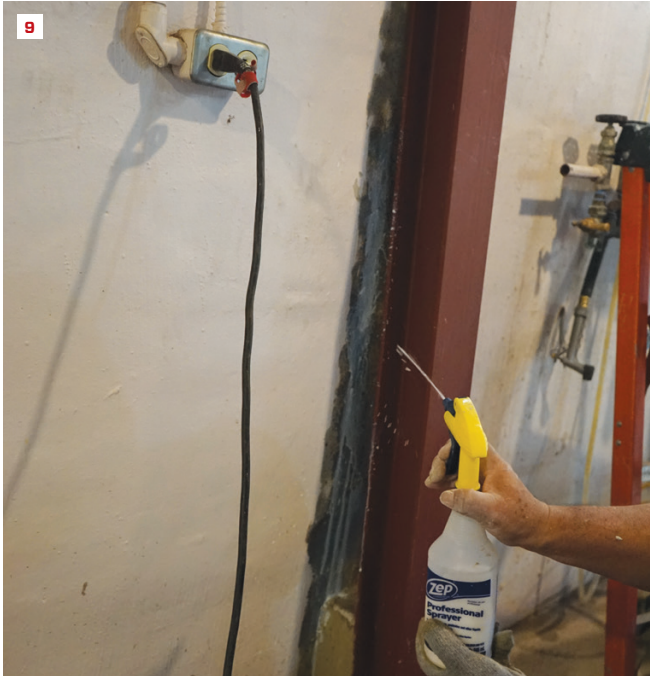
Before filling in the tapered gaps between the beams and the foundation wall, the crew sprayed liquid bonding agent on the bare concrete to help maximize adhesion (9). They then packed structural mortar into the gaps, making sure to fill them completely (10).

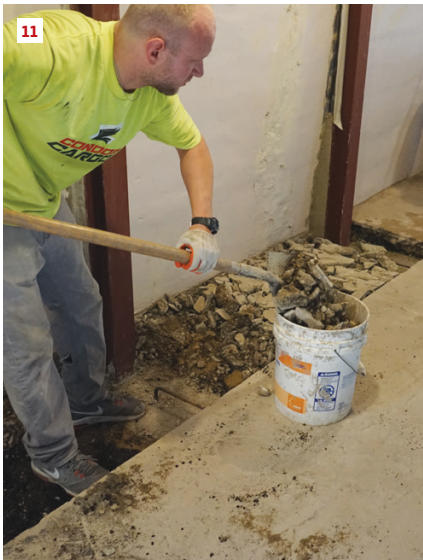
When all the beams were set and the concrete cured, the crew removed the rest of the slab between the wall and the line they scored earlier with a saw (11). They added #5 rebar along the excavated trench and attached it to pieces of rebar that they had bent over and embedded in the concrete anchors (12). To complete the project, the crew poured concrete in the trench flush with the rest of the basement floor (13). Anchored at the base and tied into the floor framing above, the vertical beams will stabilize the foundation and resist any further inward movement.
