LIGHT COMMERCIAL

Animal Hospital Rehab Workflow and planning were critical in keeping this emergency care facility running 24/7

BY DAN WATSON

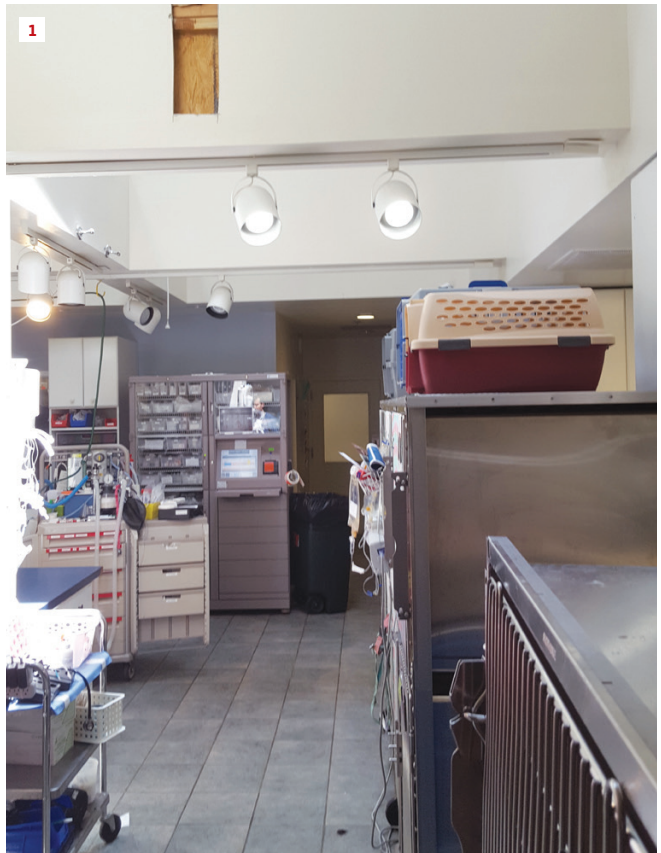
To minimize disturbance from the second-floor construction, the author added a temporary floor system to the vaulted ceiling's gridwork above this treatment area, which needed to be available to staff and patients 24 hours a day (1).

Temporary floor. The existing gridwork above the ceiling of the treatment room made a perfect support for a new, temporary floor system below the elevation of the new second-floor framing (1). Once built, the new floor would provide a noise and dust barrier between the client's space below and the active construction above.

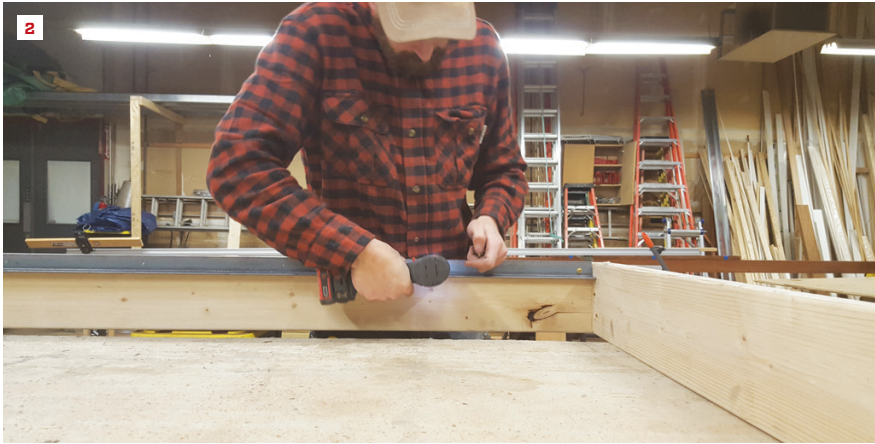
Panels for the gridwork were designed to be removable, and were prefabricated off-site (2). Framed with 2x4s, the panels rest on steel angles fastened to 2x6 frames that are fastened to the gridwork (3). The panels were taped to the gridwork from above to keep dust and debris from dropping down into the treatment room (4). After the decision was made to leave the panels permanently in place, Rockwool mineral-wool insulation was added to the assembly for both fire resistance and for soundproofing (5).

Our goal was to install the panels quickly and safely above the treatment room, so size and weight were huge concerns. We were able to limit the total weight of each panel to about 120 pounds, which meant that two or three people could easily move and lift them into place. Most of the openings in the gridwork could be filled with a single panel, which we framed with joists 16 inches on-center (2). The largest opening required two panels, which we framed with joists 12 inches on-center.

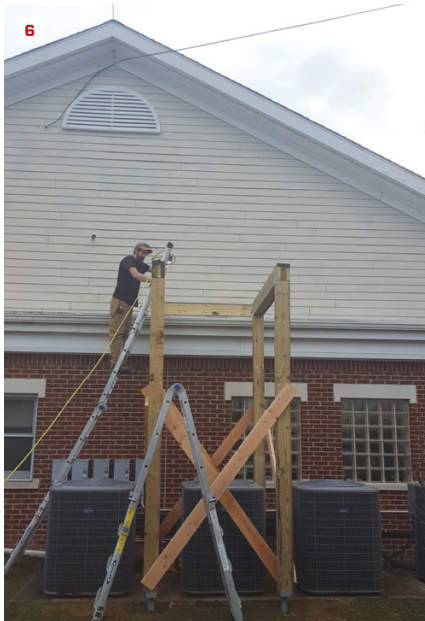
A new entry was framed on helical piles to provide outside access to the second floor (6). In a connecting hallway, a temporary ceiling allowed occupants continued use of offices and the treatment room while work proceeded in the dropped ceiling above (7). A new floor framed with I-joists and engineered beams extends in one level across the existing attic and above the old ceiling gridwork (8). The attic was filled with ductwork and other mechanicals that had to be moved as the framing progressed (9).

A single set of stairs led up to the second-floor offices, which were located in the front of the building; to access the stairs, you had to walk through busy hallways and congested work areas on the first floor. Those offices would eventually be moved to the back of the building, so to avoid traveling through the hospital, we created a new second-floor entrance directly into the attic. This kept the construction and the practice separate, allowing us to work when we needed to and bring in larger materials without issues (6).

We regularly use helical piers to support deck and porch framing, and this project was another example of their many benefits. The new landing and staircase were built above the existing air-conditioning condensers, so we had limited access and small spaces to work with. Instead of using large, traditional concrete footings, we

were able to quickly install the helical piers without impacting the condensers and immediately begin to frame the landing.

While the finished stairs were to be built parallel to the back of the building, we built the temporary stairs so that they were perpendicular. This allowed us not only to bring long joists straight into the building but also to build the second permanent stairs at any point without having to remove our utility stairs.

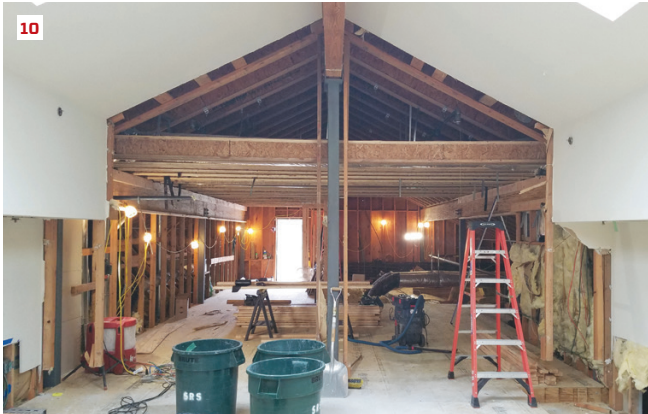
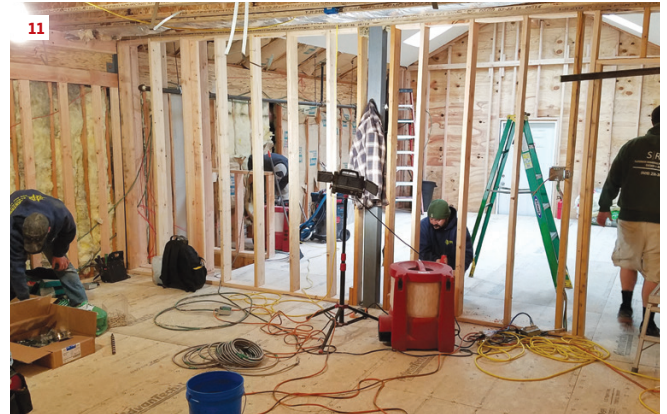
With the subfloor complete on the upper level and new ceiling joists installed (10), work could begin on framing partition walls to define new spaces and for the closets where mechanicals and panels for electrical and network equipment could be located (11). During the job, multiple BuildClean air cleaners were employed to manage dust. A new multi-head mini-split HVAC system was installed to heat the new break room and open and private office spaces on the second floor (12). In the treatment room, the gridwork ceiling was fitted with the framework for a suspended ceiling after the various lines for oxygen, suction, and the sprinkler system had been extended or reconfigured (13).

to carry one end of the new joists, while the other end of the joists bears on the existing wall. This created a hallway with closets that would be used by the office staff. We were also able to house the new network equipment in one of the closets (10, 11).

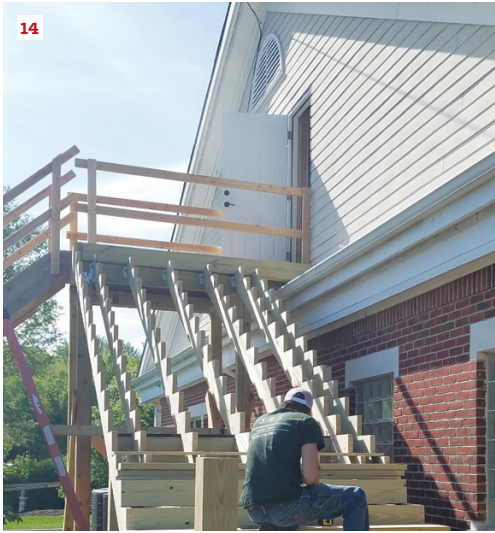
14

As the project wrapped up, the construction access was transformed into a permanent second-floor entry with a new set of finished stairs (14) and a porch roof (15). In the office at the other end of the building, the floor level steps down to the original floor level for access to an existing staircase (at left) and to a restroom (at right) (16). The new second-floor break room and workspace above the existing first-floor treatment room is lit by the building's original skylights (17).

Because the second-floor offices could not be shut down, we had to complete the new offices before we could move the staff out of their old rooms. Once they moved, our rear construction entrance would become their primary entrance—and we would be walking through the new offices to continue the project (14, 15)—so we decided to load the majority of our materials into the space between the new and the old to limit our impact on the staff. This
