BY MIKE WHALEN

## Managing Asbestos During a Remodel

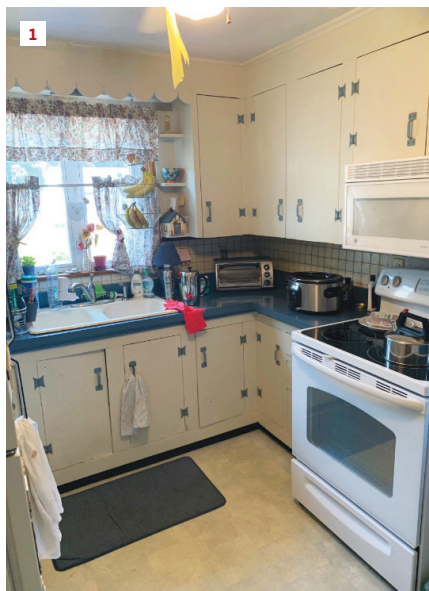
“Before” image of the kitchen in the client’s late-1950s Cape-style home (1). Work stopped when vermiculite was found in the ceiling; the author quickly sealed off the demo hole and around a ceiling light after its discovery (2). A temporary 2-by wall was framed in the middle of an archway to isolate the kitchen and to allow access to the bathroom, bedrooms, and basement (3).

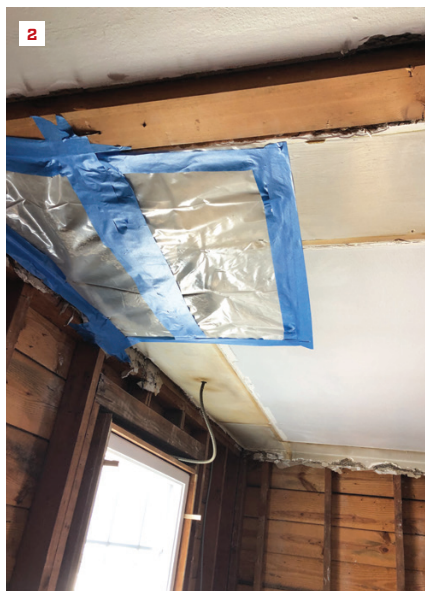
**I’m a project manager** for DBS Remodel, a residential remodeling company based in Poughkeepsie, N.Y. A few months ago, in the midst of remodeling a kitchen, we came across what we believed to be vermiculite insulation above the room’s plaster ceiling. Upon discovery, we quickly sealed up the ceiling with tape and plastic and notified the homeowners. Our clients had chosen to remain in their late-1950s Cape-style home during the remodel, so we felt a sense of urgency when reaching out to asbestos abatement companies to confirm our find.

Kevin Mathisen of Lucas Environmental Services out of Kingston, N.Y., made a jobsite visit and verified that the light granular insulation was vermiculite. He noted that while it may or may not contain asbestos, a substantial amount of vermiculite that had been sold throughout the U.S. under the trade name “Zonolite” contained varying amounts of asbestos. As a result, New York state regulations assume vermiculite to be an asbestos-containing material.

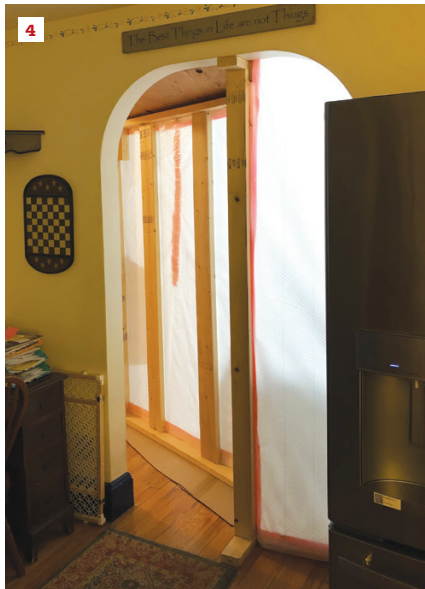
A double layer of 6-mil poly is installed on the framed wall by the abatement contractor (4). A third-party air monitoring firm sets up equipment to take a baseline air test (5). Warning signage is placed at the entrance of the containment area (6). Two layers of 6-mil reinforced fire-retardant poly, with seams sealed, cover floors, walls, and non-abatement surfaces.

Lucas later installed a double layer of woven reinforced plastic—in the middle of an open archway. This gave the clients access to their bathroom and bedroom areas. Once the third-party monitor, JPM Environmental Solutions, out of Newburgh, N.Y., had conducted baseline air testing, Lucas set up its containment shell and warning signage and cordoned off outdoor work areas. Wearing Tyvek suits, respirators, and gloves, workers wetted down the vermiculite with sprayers and bagged up the material, sealing the heavy-mil bags with duct tape. The bags were brought out to their box truck and later transported to their shop.

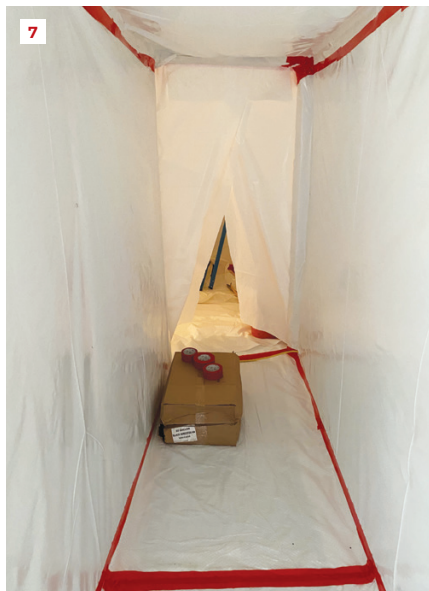
The enclosed hall shown here will be fitted out with a three-chambered decontamination/waste-out system consisting of a changing room, a shower room, and an equipment room (7). A 1,800-cfm HEPA-filtered air scrubber (8) exhausts to an exterior area that is fenced in with orange temp fencing and posted with warning signage and barrier tapes (9).

JPM Environmental then inspected the abatement work and gave the OK, and the abatement crew HEPA vacuumed and wet-wiped the work area. Once it was clean, JPM conducted another visual inspection, and upon its approval, the Lucas crew exited the work area via a three-chambered decontamination/waste-out system, which consisted of a changing room, a shower room, and an equipment room. A post-abatement settling period began, to allow the room to dry and the air to settle. A couple of days later, JPM Environmental returned to conduct its final air check to verify the amount of fibers in the air was below the legal limit.
