Repairing a Screen Porch

This makeover was done with similar materials but better, rot-resistant details

by Emanuel Silva

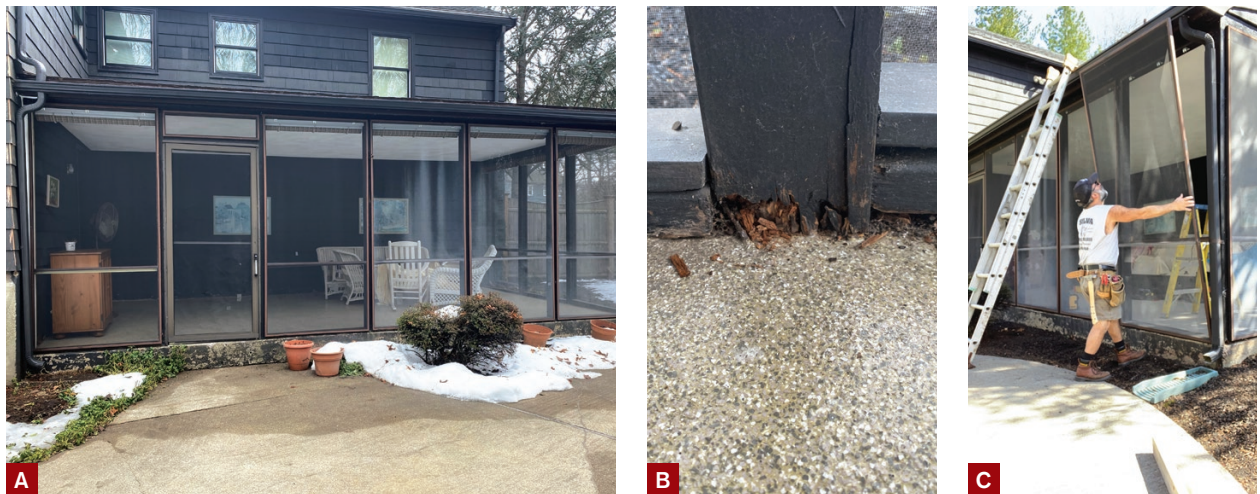
Figure 1. The roof of the existing screen porch was structurally sound (A), but the fir posts and sill plates were rotting where they were in direct contact with the porch's concrete slab floor and needed to be replaced (B). The aluminum screening in the aluminum-framed panels also needed replacement (C).

Fir, particularly the heartwood, has rot-resistant qualities but will eventually rot when bearing directly on a concrete slab that occasionally gets wet. Some pressure-treated material had been used to make repairs to the framing but mostly as applied patches to the sill plates rather than as replacements (Figure 1).

My proposed solution involved removing the aluminum screen panels and the porch framing they were attached to, replacing the framing with new material, and trimming the porch exterior with low-maintenance PVC. The project would also include repainting and rescreening the existing panels, which were otherwise in good condition, and replacing the old screen door with a new unit.

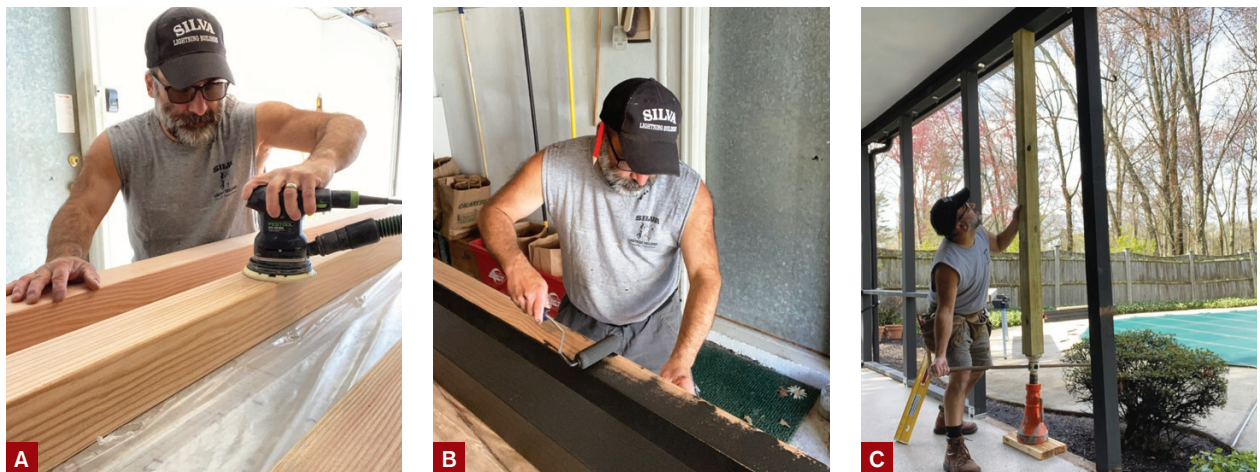
Figure 2. Prior to finishing the clear vertical-grain Douglas fir stock that the author used to replace the framing, he sanded it with 100-grit paper to open up the grain (A). This step was needed to help the wood more evenly accept the solid latex stain finish (B). The author replaced a pair of support posts at a time, centering the screw jack in the opening and raising it just enough to take the weight of the roof off of the two posts (C).

clear, vertical-grain Douglas fir. Because the stock came with a smoothly sanded surface, I decided to scuff-sand it with 100-grit paper to raise the grain so that it would better accept the finish. Then, before installation, I rolled on two coats of Benjamin Moore Arborcoat exterior solid stain, coating all four sides of each piece (Figure 2).

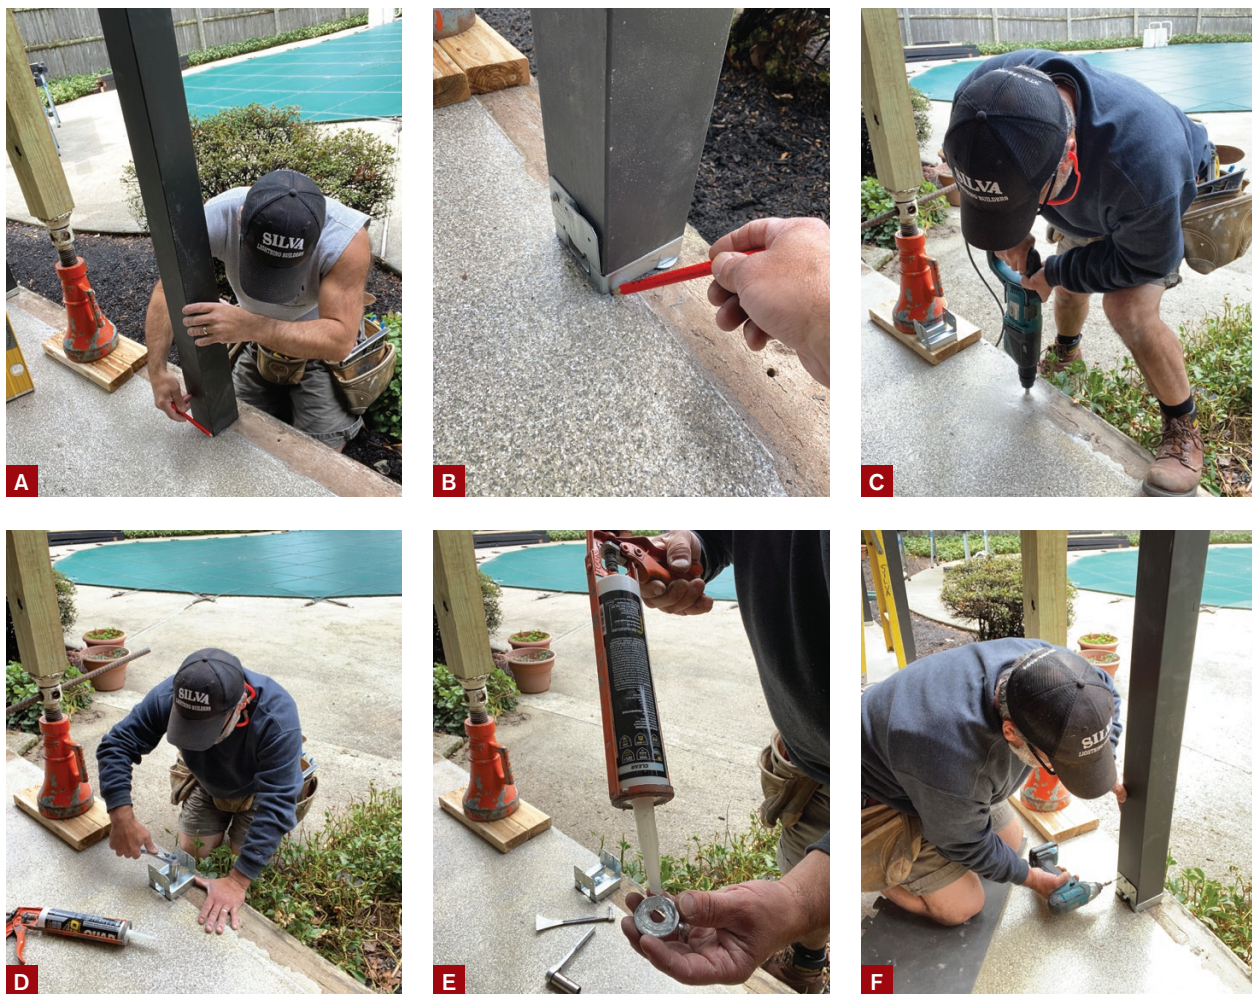
Figure 3. At each post location, the author traced the post's footprint onto the slab (A), then recut the post to fit the metal post base and traced again around the post base (B). Next, he drilled a 1/2-inch-diameter hole for the 1/2-inch-diameter wedge anchor that he used to fasten the metal base to the slab (C). As he tightened down the nut (D), he checked the base for level and used metal washers to shim between the slab and the base as needed; a dab of adhesive sealant on the washers ensured that they'd stay put under the weight of the post during assembly (E). Then he inserted the post and fastened it to the metal hardware with structural screws (F).

the new post so that it was plumb in both directions from the bearing point on the beam, which I had marked in pencil prior to removing the original post. After outlining the position of the base of the post on the slab, I removed the post and trimmed it to length to accommodate the metal post base. Not only do the post bases anchor the posts to the slab, they also raise the wood above the concrete by an inch to allow for drainage and keep the base of the post from contacting the concrete (**Figure 3**).

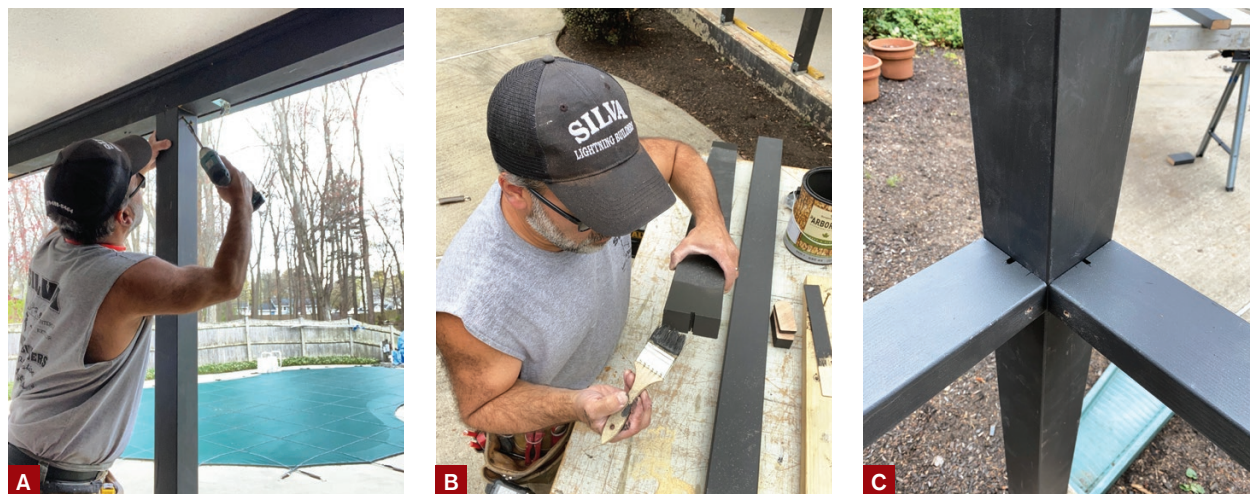
Figure 4. After anchoring the base of the post to the slab, the author checked that the post was still plumb and then drove coated U2 structural screws through the top of the post into the roof framing (A). When cutting the horizontal 2x4 framing pieces, the author notched the ends so that water could drain from the joint (B). Coating the end cuts and notches with stain helps prevent the end grain from absorbing moisture (C).

The panel openings are framed by horizontal 2x4s that span between the posts both at their bases and at railing height 36 inches above the floor. To protect these framing members from rot, I didn't anchor the sills directly to the slab but instead left a 1/2-inch gap between the bottoms of the 2x4 sills and the slab, which would later be covered by PVC trim. I also notched the ends of all the 2x4s that make up the sill pieces and the intermediate railing sections to allow any water that collects at the joint between the horizontal and vertical framing members to drain instead of getting trapped (Figure 4).

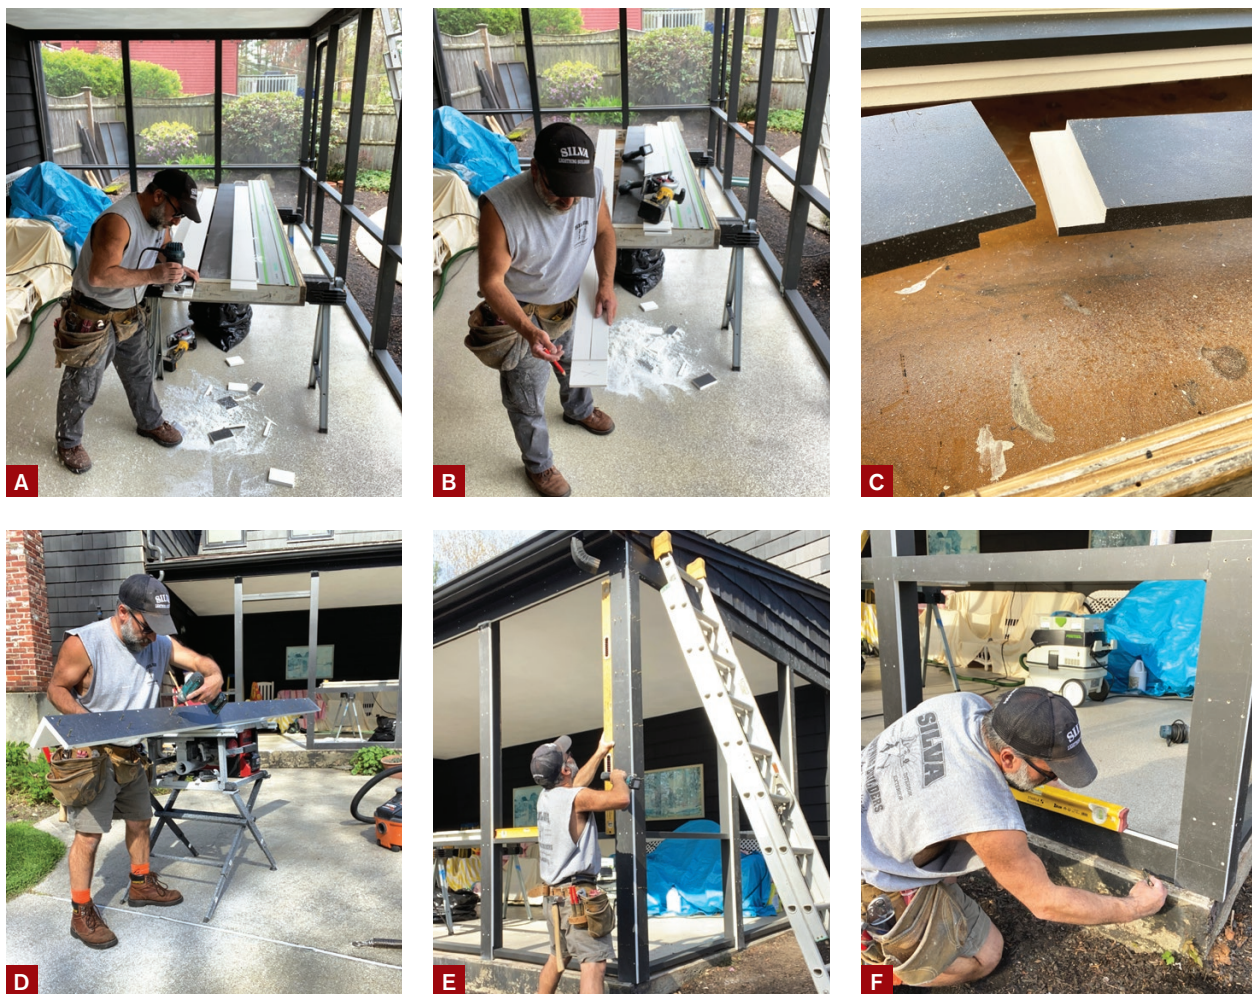
Figure 5. After cutting the PVC post claddings to size, the author used a router to relieve the backs to fit over the metal post bases (A). He also routed $\frac{1}{4}$ -inch square grooves down their backs to create a drainage channel (B). The long fascia was joined together from several pieces with half-lap joints, a configuration that allows the PVC to move with changes in temperature without opening up the joints (C). The author prefabricated the corner from two pieces of PVC joined together with PVC glue and Cortex screws (D). Cortex screws were used to fasten the PVC trim to the framing (E). Scribing the bottom rails to the irregular concrete slab ensured a tight fit (F).

which was based on the old post locations. Because the original posts were—in some cases—out of plumb, the screen panels would not have fit several of the new openings without the PVC overlay. To me, it was more important to fabricate the PVC trim so that the panel openings would be square and uniformly sized than to follow the roofline, which sagged a little bit. I also used a router to relieve the back of the trim at the bottom to fit over the metal post bases (Figure 5).

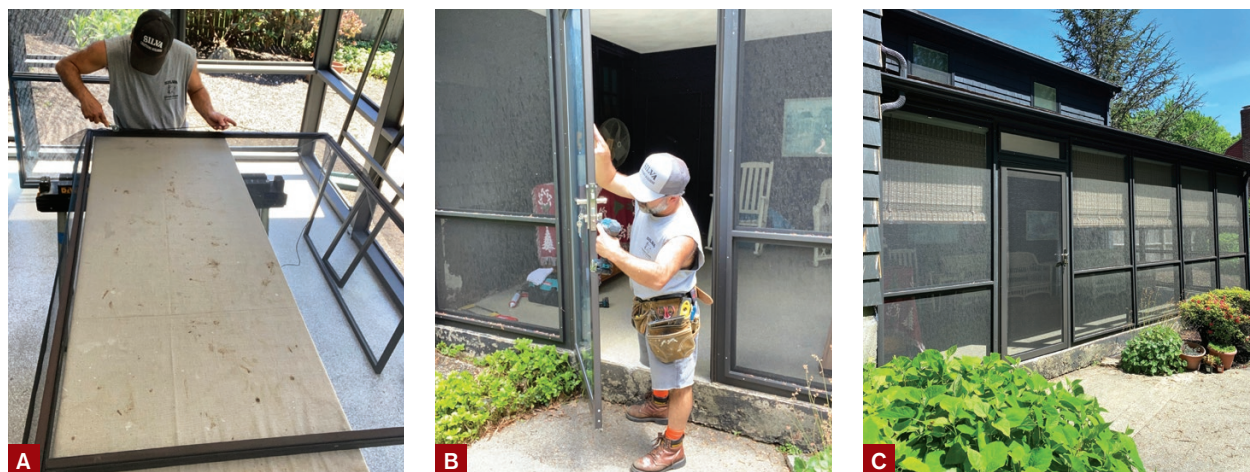
Figure 7. After cleaning and painting the aluminum screen frames, the author installed new fiberglass mesh screening (A). After reinstalling the screen panels, he wrapped up the project with a new screen door (B, C).

When splining screening into a frame, I've tried several different methods to apply uniform tension to the screening. I used to install separate splines for each side, first tensioning the longer parallel sides and then the top and bottom, but I've found it works just as well to use a single spline, starting at one corner and working my way around the screen frame to get a snug fit (Figure 7).
