I N S T A L L I N G

Water-Managed

Synthetic

Stucco

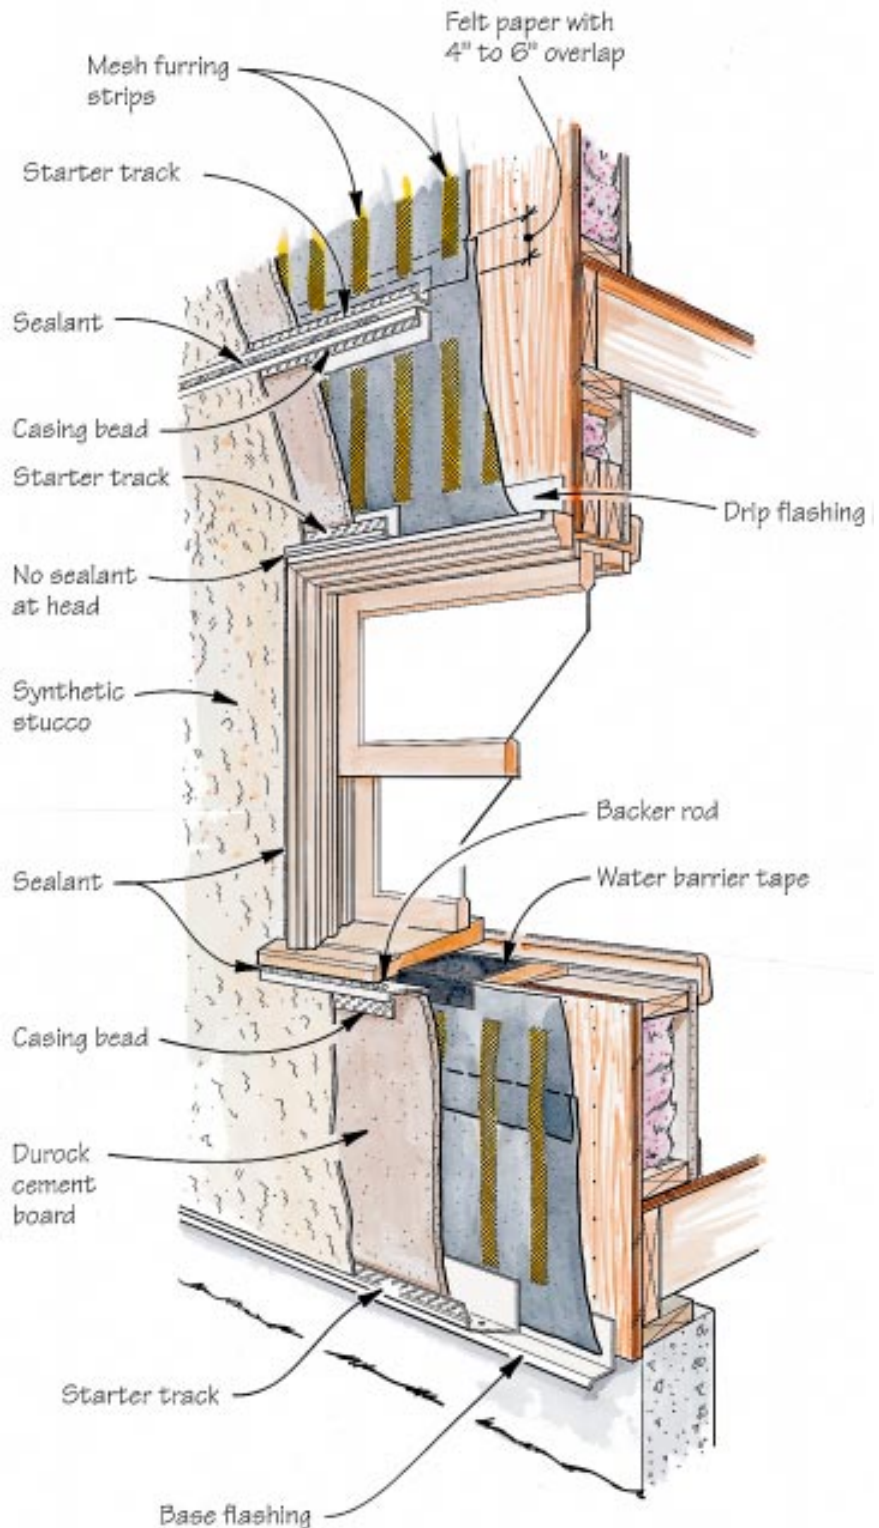
Figure 1. USG's water-managed system uses Durock cement board over a moisture-resistant drainage plane. Any water leaking past the stucco skin is directed to weep holes at the bottom of the wall.

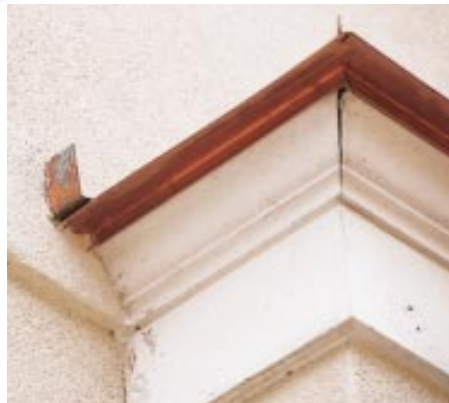
With the sheathing removed, we can see any additional water damage that we missed during the initial search. On this house, the south wall (which faced the street) was in worse shape than we thought. The whole wall was rotted and had to be reframed, reinsulated, and resheathed, and all of the windows and doors had to be replaced (Figure 5). The source of the leak appeared to be missing copper kick-out flashings at roof/sidewall junctions, which we installed (Figure 6, next page).

Figure 6. Missing kick-out flashings at roof-wall junctions are a common source of leaks in EIFS failures. The author prefers a heavy-gauge copper for these flashings.

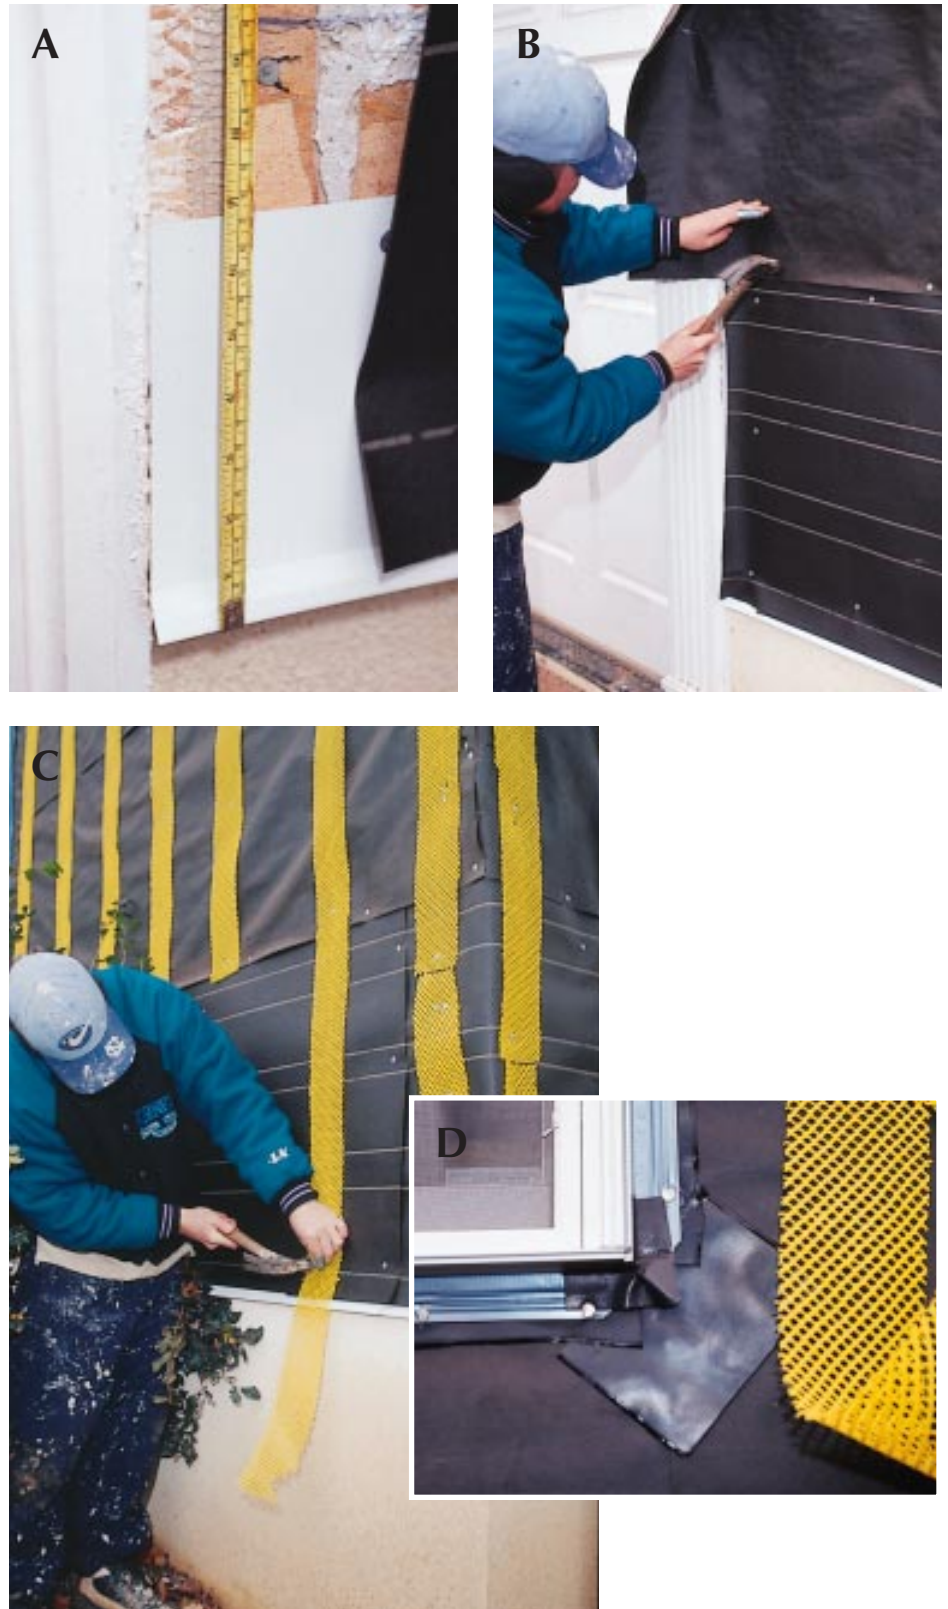
Figure 7. Installation of the drainage plane begins with vinyl or metal base flashing (A). The building is then wrapped in felt paper or Stuccowrap, with 4- to 6-inch overlaps at the joints (B), followed by staple-on mesh furring strips, which provide an air space behind the Durock (C). Extra care is taken to make windows and other openings watertight (D), using a self-sealing barrier tape where needed.

Installation of the DuroScreen system begins with the base flashing, followed by the barrier paper (Figure 7). On this job, we used 15-lb. felt paper. (As an alternative to felt paper, DuPont Stuccowrap was recently approved by USG for use with its systems. Similar to Tyvek, Stuccowrap is ribbed to encourage drainage.) The lowest course of felt is lapped over the upper leg of the base

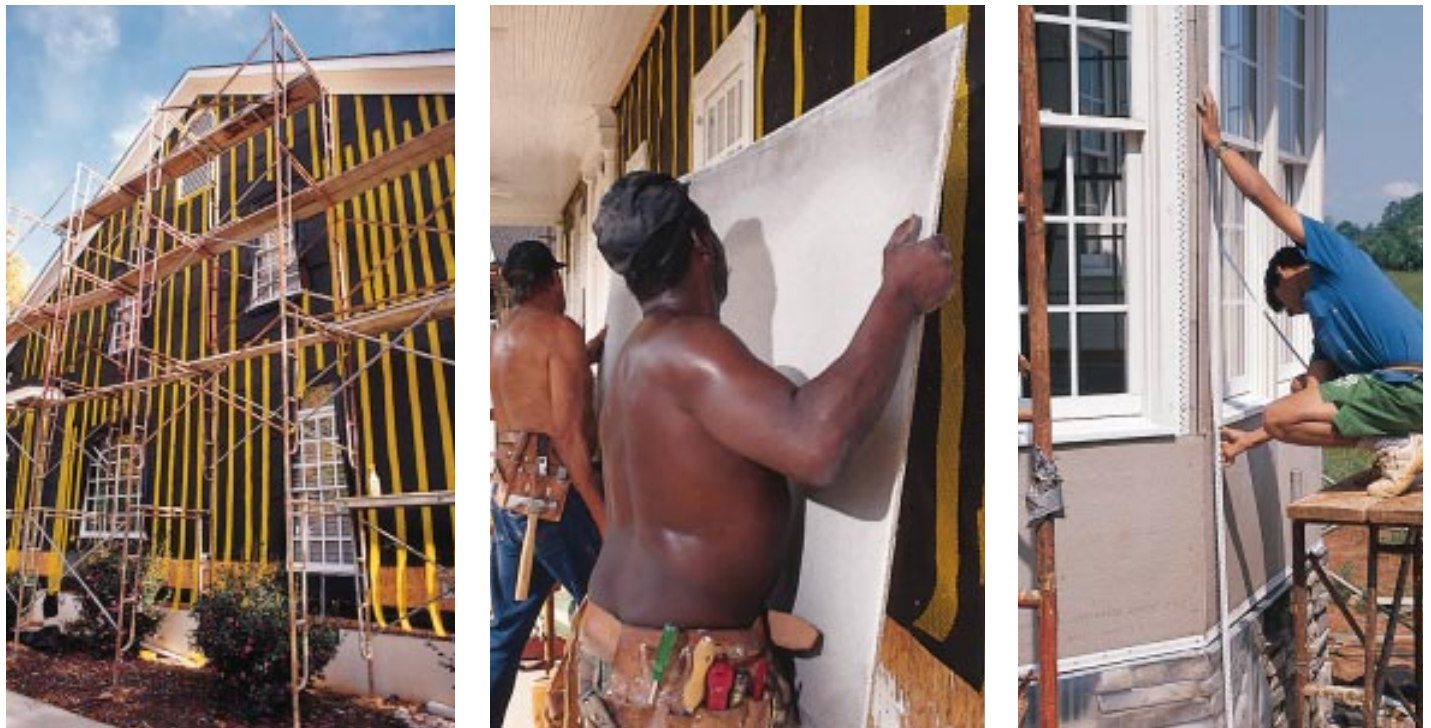
Figure 8. With the drainage plane and scaffolding in place (left), the Durock cement board panels are applied in a staggered pattern (middle). Spaces between panels provide a keyway for the stucco. A vinyl starter bead maintains a clean reveal along the exposed bottom edge of the cement board (right).

We use 4x8 sheets for the first two courses, which we can reach from the ground, and 32-inch-wide sheets for everything higher (Figure 8, page 44). It generally takes two men to handle a 4x8 sheet, plus an additional man per level of scaffolding to pass it up. The smaller panels can be managed by one man.

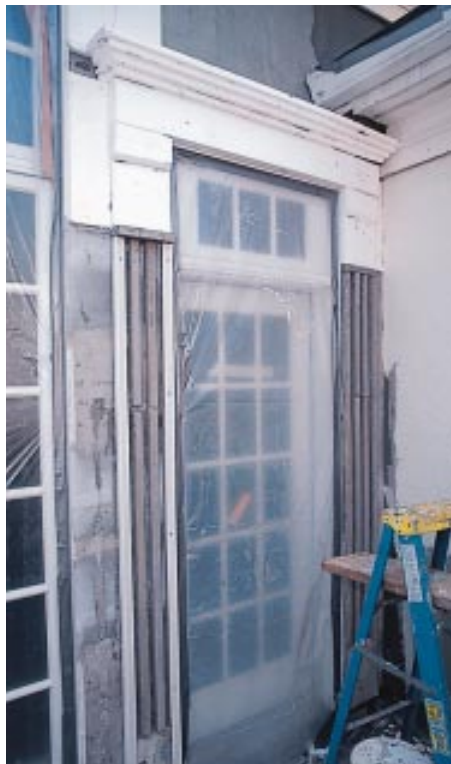
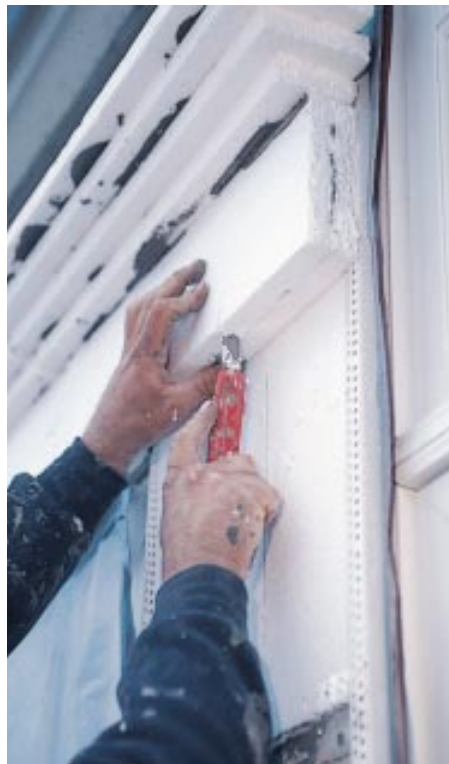
Figure 9. Hand-carved foam details are common in synthetic stucco systems (left). For extra durability, the foam trim is either bedded in mesh tape or capped with vinyl beads, as shown here (right).

On this house, as is true with many houses using a synthetic stucco system, most openings called for built-up foam detailing (Figure 9). To strengthen these foam details, the system calls for either applying trim bead along the edges or "back-wrapping" the foam using an exterior-grade fiber mesh. For typical rectangular foam details, the mesh is cut wide enough so that it extends 2 inches under the trim, wraps completely around the three exposed faces, and then extends 2 inches onto the face of the Durock. It's left loose on the face of the foam

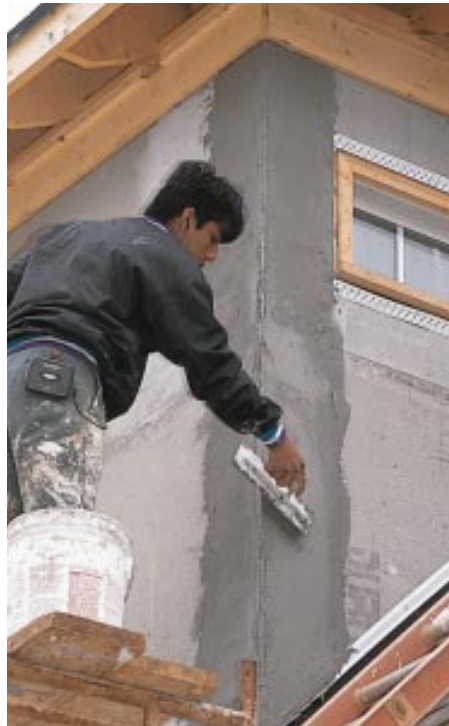
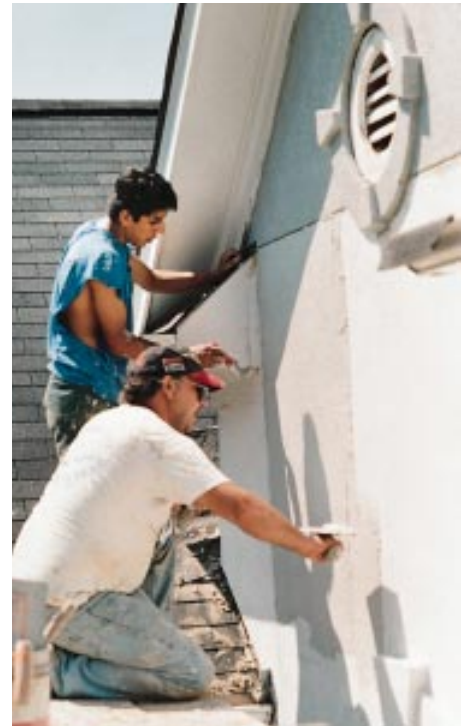
Figure 10. The base coat plaster is first used to bed all joints and to fill inside and outside corners (left). Once the bedding cures, the base coat is troweled onto an entire elevation at one time to avoid cold joints. After the base coat has cured for 24 hours, the finish coat is troweled on and textured, much like conventional stucco (right).

The stucco goes on in several stages: First the joints are bedded, then two layers of base coat are applied, followed by the finish coating (Figure 10).
