Replacing a Slab Foundation

When the original builder flubs a foundation, someone else has to clean up the mess

by Mark Reinmiller

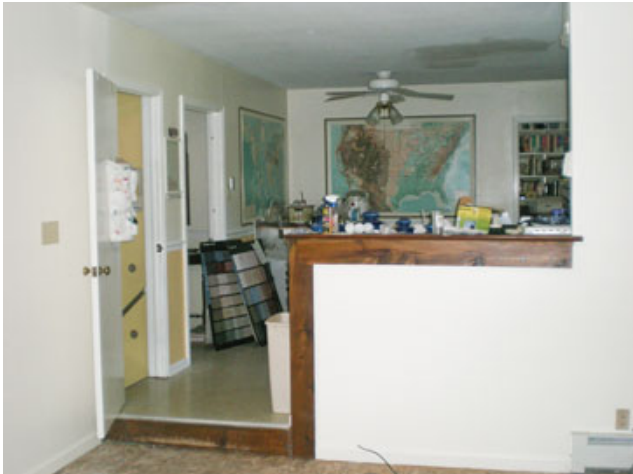
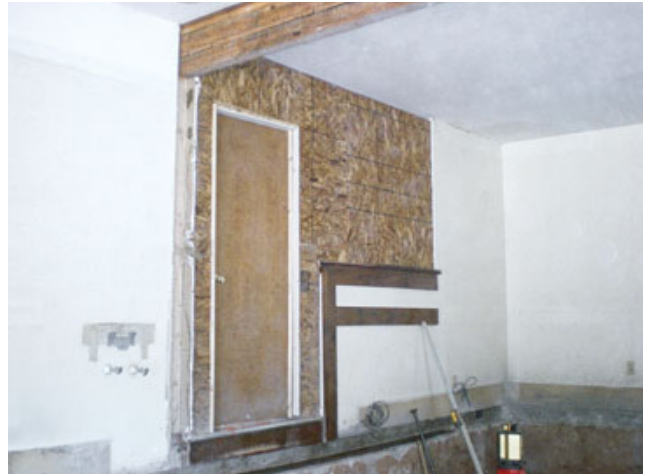
Figure 3. To prevent demolition dust from spilling into the living space beyond (left), the contractor built a temporary wall with a passage door (right).

Working in an occupied house while performing a major renovation can be a hassle for everyone. In this project, the kitchen in the main part of the house opened directly onto the family room. To prevent the demolition and excavation from spilling into the kitchen, we first framed a wall between the rooms and sheathed it with OSB (Figure 3, page 4). Portable ventilation fans in a sliding-glass door opening at the rear of the family room and in the laundry room helped control exhaust fumes from the equipment used during excavation.
