An Energy Retrofit in Stages

In the real world of tight budgets, energy paybacks are elusive; improved comfort is the payoff

by Jim Olson

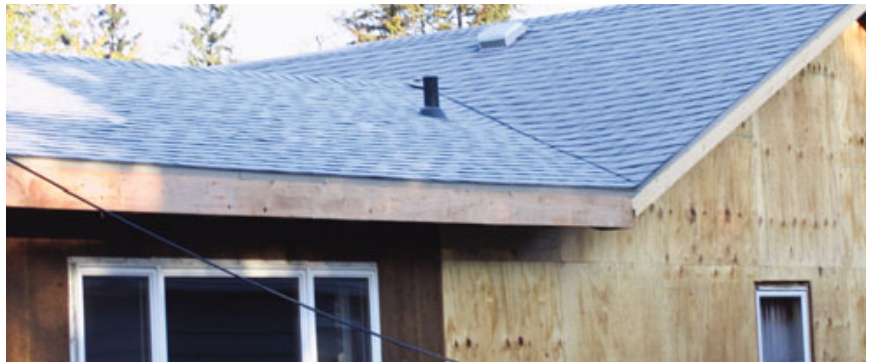
Figure 5. Foil-faced polyiso board, screwed to the addition roof deck (top), supplements the original batts, which were left in place between the rafters. Joints between panels — and the intersection with the board deck of the original house, visible at rear — were sealed with spray foam. The gable-end rake of the original house was extended to meet the addition overhang, providing improved weather protection and a cleaner appearance (right).

Exterior foam. Through a local commercial builder, I got a great deal on about a hundred 4-foot-by-13-foot sheets of foil-faced polyiso board left over from a large job. With the air leaks in the roof taken care of, we laid the sheets of foam board directly on top of the plywood, butting

them against a new subfascia sized to cover the edges of the foam and the plywood sheathing that would go on over it (Figure 5, page 4).
