Hardware for Ground-Contact Lumber

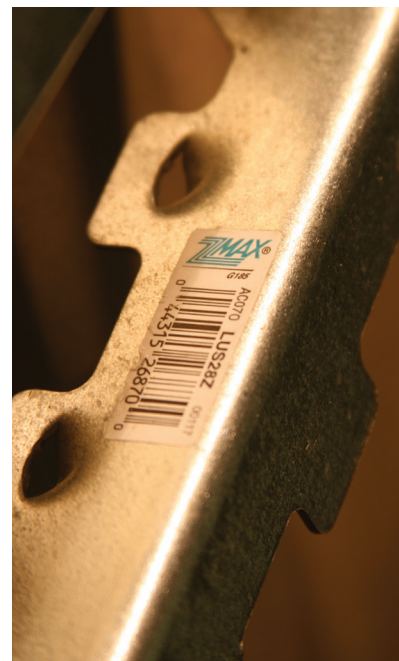
While metal hardware with a G185 zinc coating is generally acceptable for use with PT lumber rated for above-ground use (UC3B), PT lumber rated for ground contact (UC4A) may require metal hardware with more corrosion resistance.

A Robert Leichti, an engineering manager in the Fastening Systems department at Simpson Strong-Tie, responds: Even though changes to AWPA U1 and AC326 may push up some application specifications one use category—mostly from UC3B (above ground) to UC4A (ground contact), and to a lesser extent from UC4A to UC4B (heavy-duty ground contact)—the actual chemical retention levels for UC3B, UC4A, and UC4B have not changed.

Simpson Strong-Tie tuned its corrosion-resistance classifications to these categories in 2014. For above-ground ACQ-C, ACQ-D, CA-B, and CBA-A treatments without ammonia (western treaters typically use ammonia as an additional carrier since western species are more difficult to treat than southern yellow pine), Simpson recommends HDG hardware with a minimum G185 zinc coating. For PT lumber with retention levels greater than 0.40 (for ACQ and MCQ), 0.41 (for CBA-A), or 0.21 pcf (for CA-B)—the AWPA-specified retention levels for UC4A (ground contact) treated lumber—Simpson continues to recommend stainless steel hardware. Because our recommendations refer to the use categories and their retentions, we don't expect our corrosion-resistance and hardware recommendations to change, although for materials that push from UC4A to UC4B, the recommendations in UC4B will be stainless steel, just as it is now. Also, critical structural components should already be fastened with stainless steel to mitigate risk.
