Restoring a Gothic Porch

BY MARC BRAHANEY

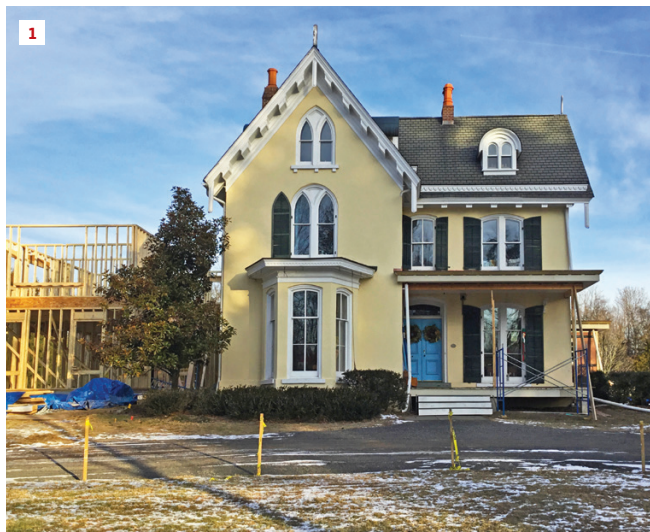
The author rebuilt the Gothic-style porch as part of a major addition and exterior restoration project (1). A new factory-milled pilaster was installed a couple of feet beyond the previous pilaster location (due to the widening of the porch) (2). The pilasters, columns, crown molding, trim stock, and brackets were all made from Boral (supplied by Duration) (3). The only non-Boral material used was the beadboard ceiling.

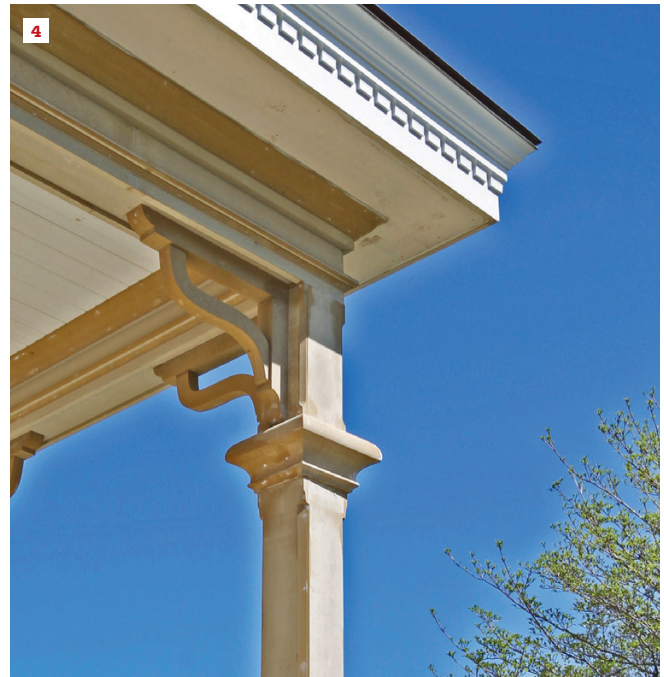
At the fascia, Boral crown molding and dentil trim from Duration covered a raised perimeter curb needed for roof drainage (4). Elsewhere on the home, new window sills and highly decorative trim for box gutters were also made from milled Boral. Finishing up, the porch trim is to be painted white, nicely offsetting the home's light yellow stucco cladding and the dark green (almost black) shutters (5).

In the interim, we conventionally framed the porch deck and installed 5/4x4 T&G Douglas fir decking, which we painted later. The roof, which would be covered with new flat-seam copper, was framed to provide sloped contours pitched towards two downspouts at the roof's edge (a raised curb maintained a level height around the roof's perimeter). We temporarily braced and supported the roof and waited for our new moldings and trim to arrive on site.
