BY JIM BRADLEY AND CHRIS WEST

Tracing Air Leaks With a Blower Door

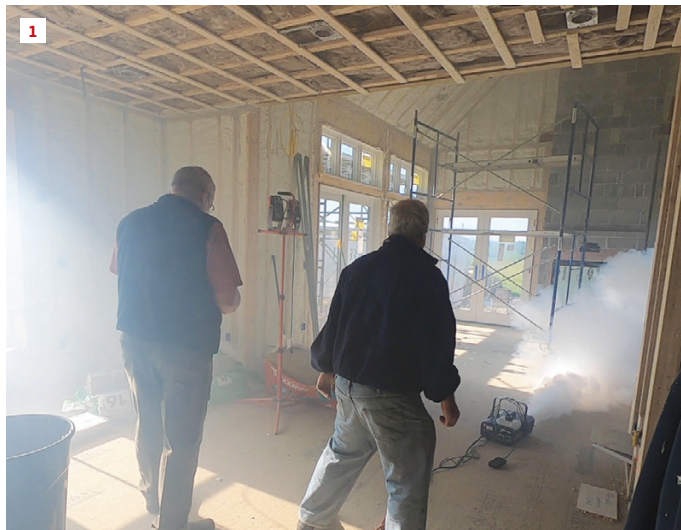
To begin a “smoke check,” the authors fill a home with dense fog produced by a high-volume theatrical fog machine (1).

To perform smoke checks, we use a theatrical fog machine (1). We first fog a home’s interior, then set up a Minneapolis Blower Door to pressurize the home and push the fog to the exterior through any open seams or gaps (2). This pressure test helps locate what we refer to as “areas of opportunity”—a last chance to easily tighten up the home’s air barrier prior to drywalling and installing the exterior cladding. Putting the effort in to track these down can often add up to hundreds of cfm worth of leakage reduction.

Starting out, we set up the blower-door assembly with the fan oriented to blow inwards. We then filled the entire home with "smoke" using a high-volume theatrical fog machine (chauvetdj.com). The machine burns a special fluid to create the fog, which is innocuous but has a faint odor. It took about 20 minutes to fill the entire 4,500-square-foot

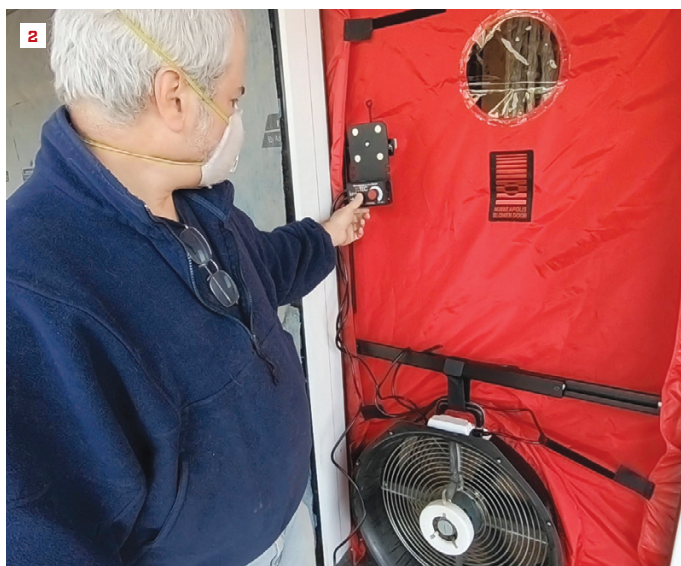
With the blower-door fan blowing inwards, co-author Chris West starts to pressurize the home, pushing the fog to the exterior (2).

home. We then pressurized the house with the blower door to push the fog out through the home's primary air barrier and inspected the home's exterior perimeter for air leakage.

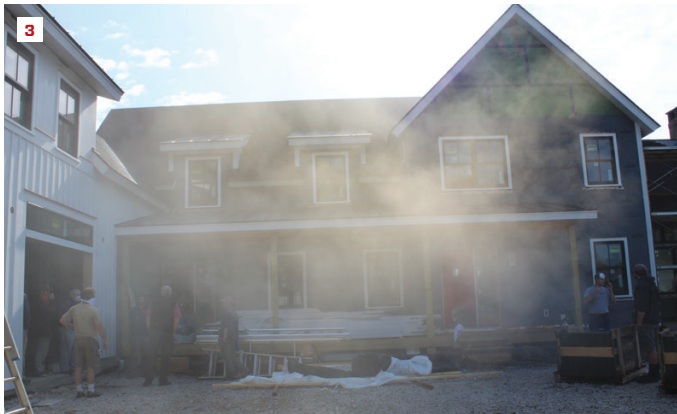
With the building pressurized, fog could be seen escaping from two doghouse dormers at their roof-to-wall junctures (3).

We could see smoke coming out a pair of second-floor doghouse dormers along the rake edges of their roofs (3). Dormers are somewhat notorious; because they are framed above the roofline, they are difficult to air-seal and small air leaks are common. More noticeable was the smoke emanating from the double-hung windows located at the second-floor living space above the garage (double-hungs are known to be less airtight than casements or European tilt-and-turns). The three windows were identical, but one of them was leaking more than the other two (4). The builder's crew broke out their ladders and determined the smoke was leaking from around the window's frame and not from its taped-off flanges (5). The window manufacturer was notified about the leaky unit.

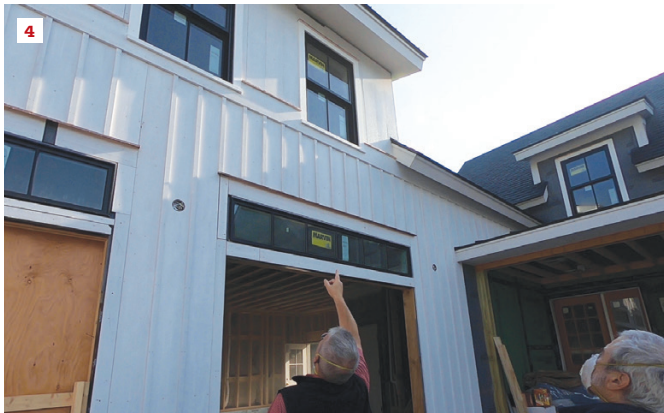
Co-author Jim Bradley points to smoke leaking from double-hung windows in living space above the garage (4). After checking the window openings and dormer framing, workers determined that the window units themselves were leaking (5).

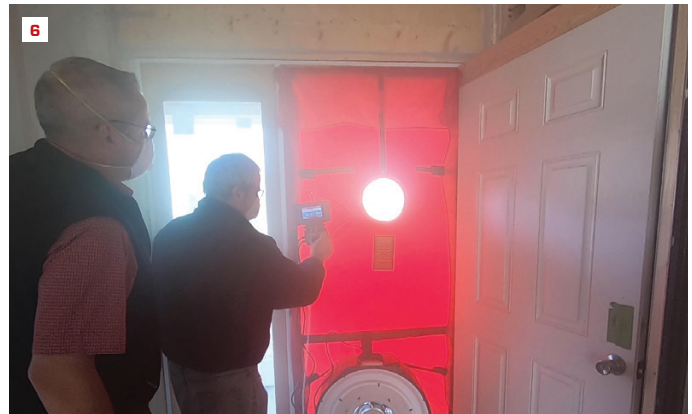
With the smoke test completed, the authors depressurized the home and performed a blower door test (6).

Blower door test. With the smoke check completed, we can turn the fan around and depressurize the house to find our baseline ACH rating numbers for the client, which turned out to be 1 ACH50, well under the code maximum airflow of 3 ACH50, negating the need for another test (6).

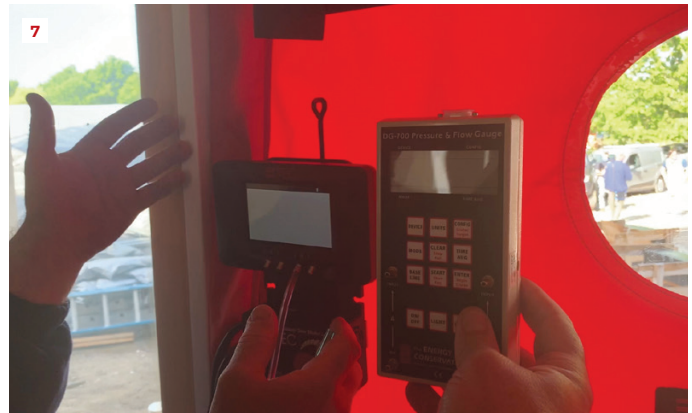
The authors used a new TEC DG-1000 manometer—here compared with an older DG 700 manometer—for the blower door test (7). The DG 1000 is much more intuitive, graphically showing where to connect red and green diagnostic tubing (8).

As an aside, we now use a TEC DG-1000 Pressure and Flow Gauge manufactured by The Energy Conservatory to calculate a home's ACH rate. We've found its new DG-1000 manometer much more intuitive than its old workhorse DG 700 model (7). A high-resolution touchscreen graphically shows you such items as what size rings you need on the blower door fan, and what pressure taps to hook the red and green diagnostic tubing to, depending on the airflow-measuring task (8). TEC also has an app available that enables you to sync your smartphone to the manometer, which allows you to operate the DG-1000 remotely—it's a big step up from the older model.
